Investment Grade Audit

Investment Grade Audit For The Town of Belleair

Presented By: ABM Building Services, LLC.

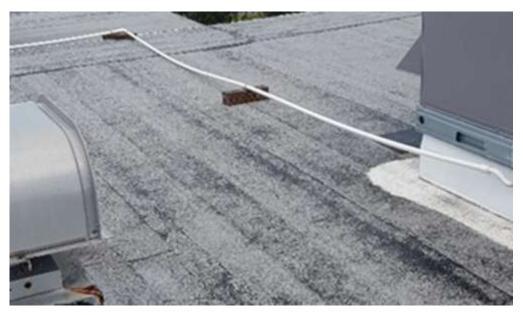
The drain and electrical wiring lines for these 4 units are on wooden blocks and the PVC piping has started sagging causing double traps on drain lines.

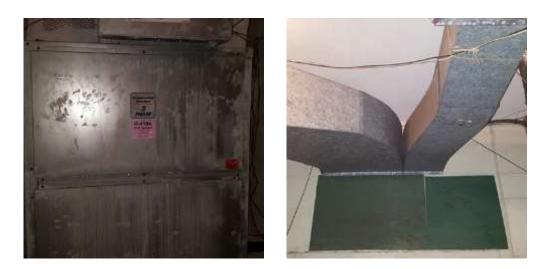
The east mechanical room is not air conditioned and the air handling unit is beginning to rust due to condensation onto the frame. The vent to the outside air is closed.

The slotted double doors on the East Mechanical room will be replaced. This mechanical room contains two (2) air conditioning air handlers and a larger electrical panel. We will condition this space to help with the rust and corrosion and to extend the life of the equipment in this space.

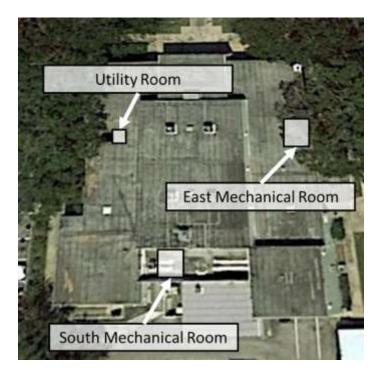
Figure 1 - South Mechanical Room

Upon initial inspection, ABM was notified that the electrical panel in the south electrical room had been "bypassed" when the new AC units were installed on the roof. This panel is adjacent to the ladder to the roof. ABM subsequently tested this panel and found that it was actually active and energized with more than 50A service.

The panel was mounted to alleviate the immediate safety concern, but a thorough investigation identified various code violations and issues with the outdated electrical infrastructure.

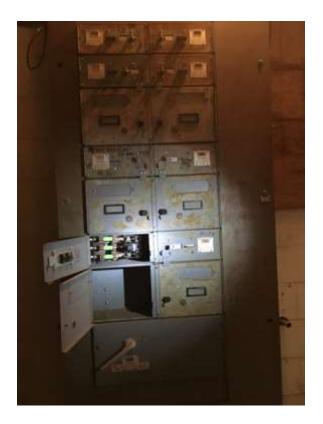
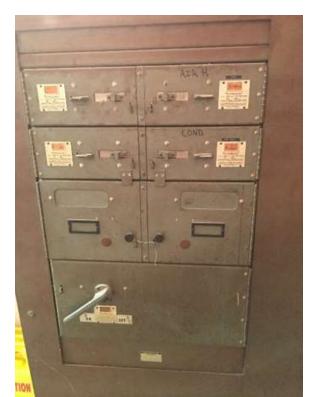
NEC Violations!

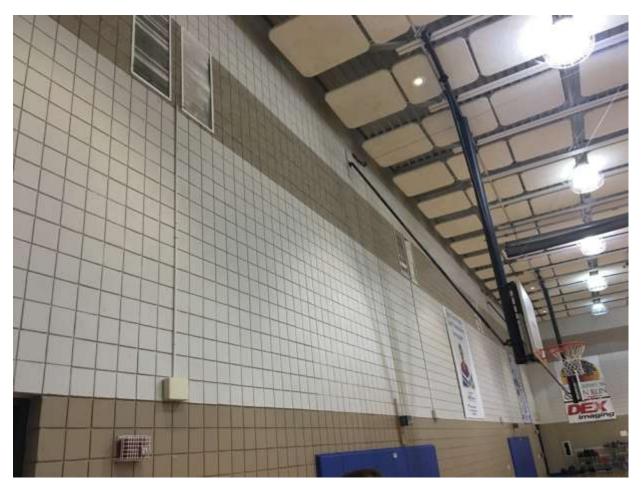
Gym units are being controlled by individual thermostats. Note the gym air grilles at the top of the photo. All of these grilles will be replaced with gym specific grilles.

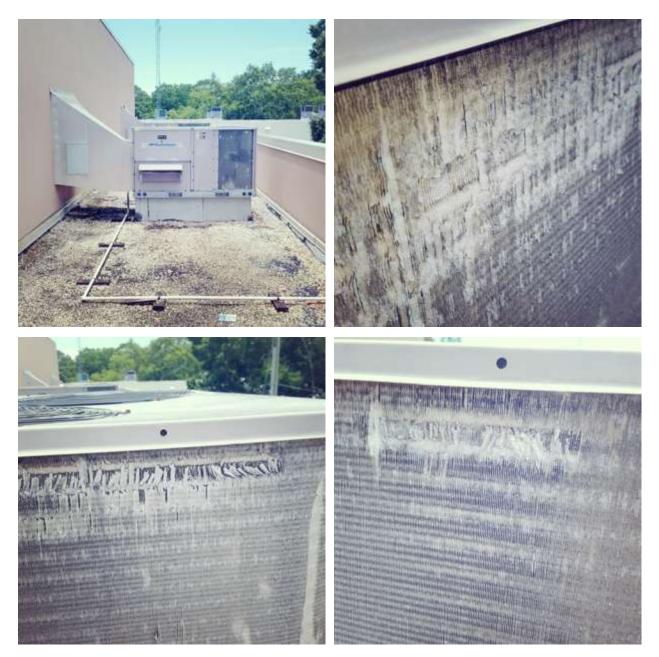
Examples of deteriorated condenser coils that effect the energy consumption and efficiency of the equipment. Also note the drain line on the roof. These will be cleaned up and proper stands will be installed on all units.

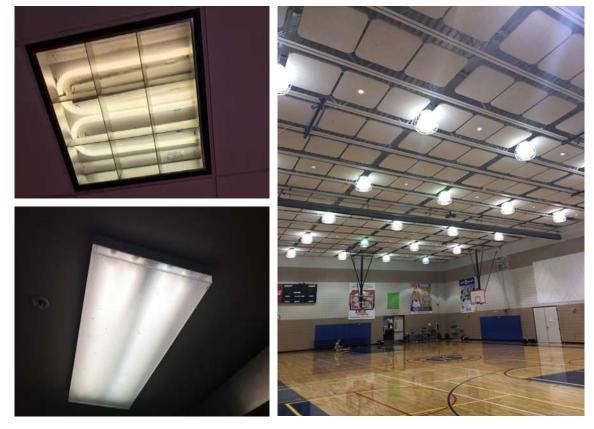
Note: The metal halide (MH) lamps in the gyms are highly inefficient and have long "warm up" times that causes staff to tum them on well before the gyms are being used. The existing metal halide fixtures are also showing signs of "color shift" which is common as MH lamps degrade. The MH lamps have a short average rated life of 20,000 hrs. When these high reach lamps fail, the cost and labor time is high as town staff must secure a lift to replace lamps.

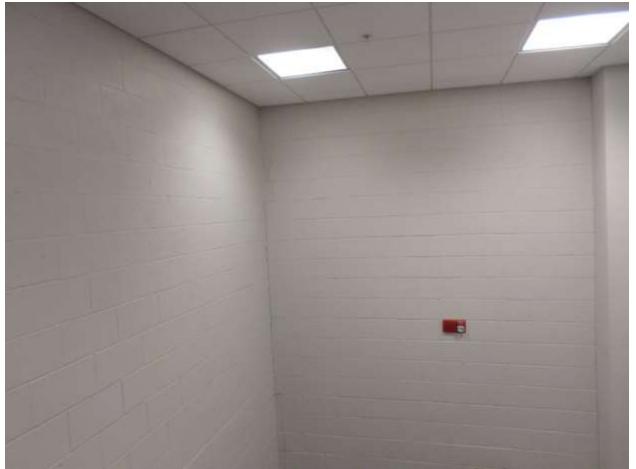
There is a crack in the stairwell that must be sealed.

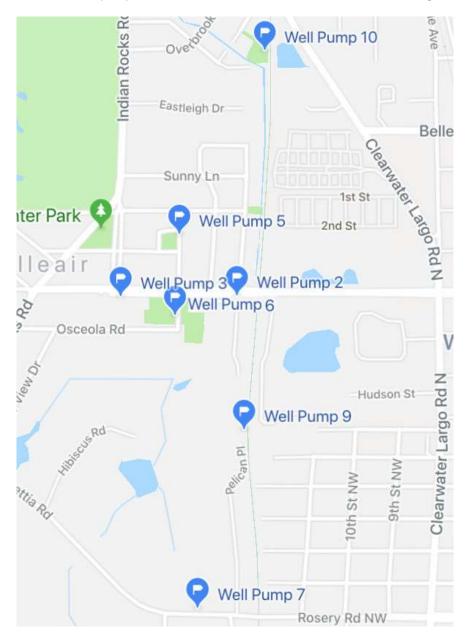
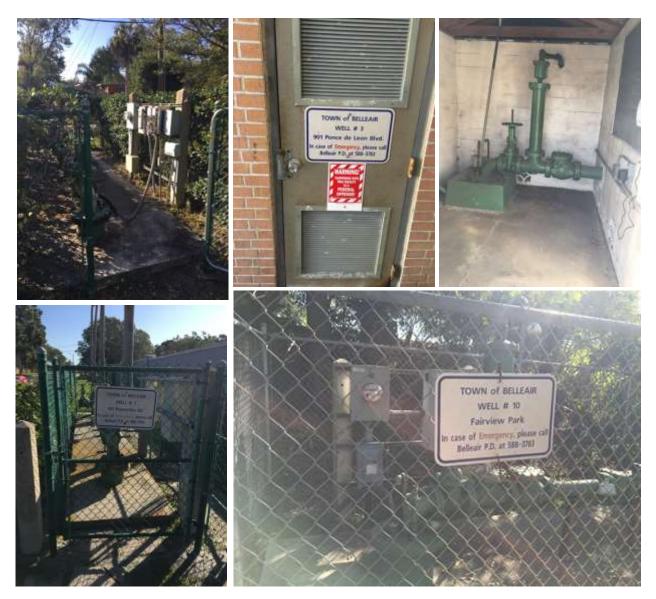
Currently there are not any flow control devices on the town's 7 well pumps other than the outlet valves. This is causing premature wear on the pumps and motors, excessive town labor resources and higher energy costs.

ABM along with our electrical partner will install 7 properly sized Mitsubishi Variable Frequency Drive (VFD) units with bypasses at each of the 7 well pumps. These VFD's will be installed on the existing metal frame work located at the sites and will be tied into the starters and pumps by a licensed electrician with ABM oversight. Final adjustments will be made with the input from the Water Department regarding Gallons per Minute (GPM) flow rates that are desired. Training will be provided on the use of these VFD's. There are a few well pumps that show low insulation reading on the windings. The VFD's installed on these pump motors can cause additional stress to these windings and cause motor failure. ABM will not be responsible for any motor failures on existing well pump motors.
