Town of Belleair

Meeting Agenda Infrastructure Board

[21-0018](#) Draft Bridge & Seawall Evaluation Report

Attachments: [2021-01-08 Belleair Bridge Seawall Inspection Report draft \(2\).pdf](#)

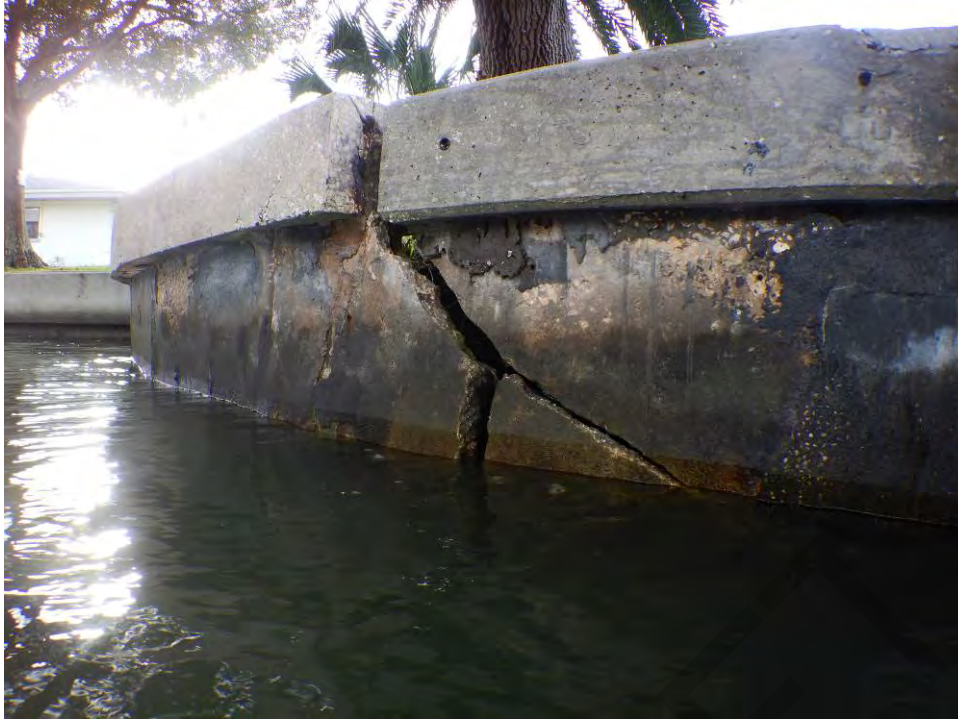
Figure 4-4: Southwest Wall – Opening in the panel and cap with void

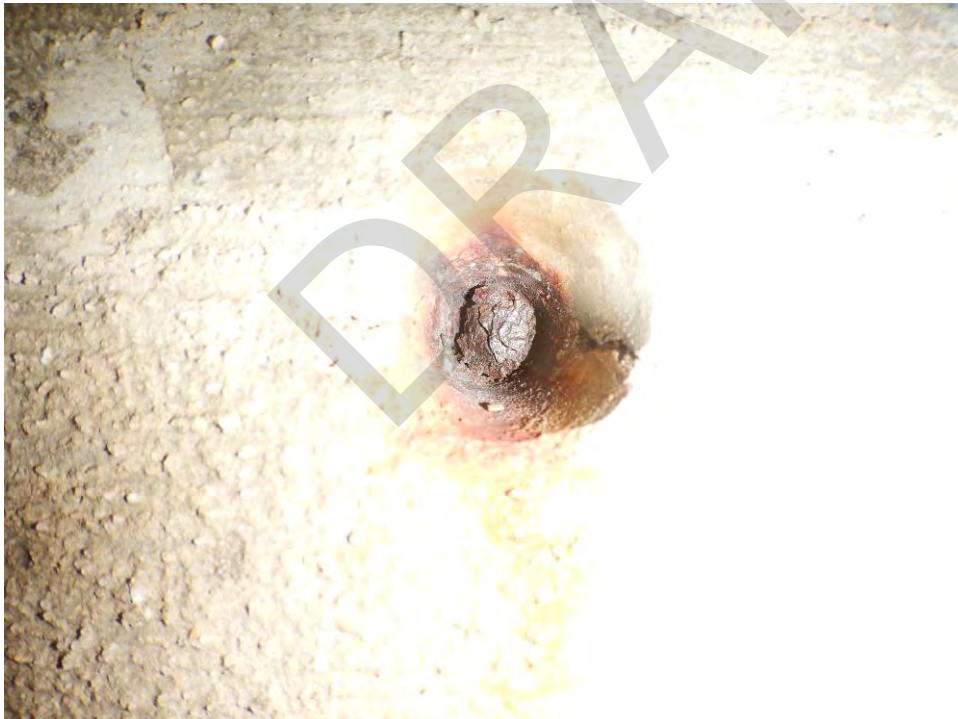
Figure 4-5: Corrosion to steel at unpatched form tie holes in face of abutment

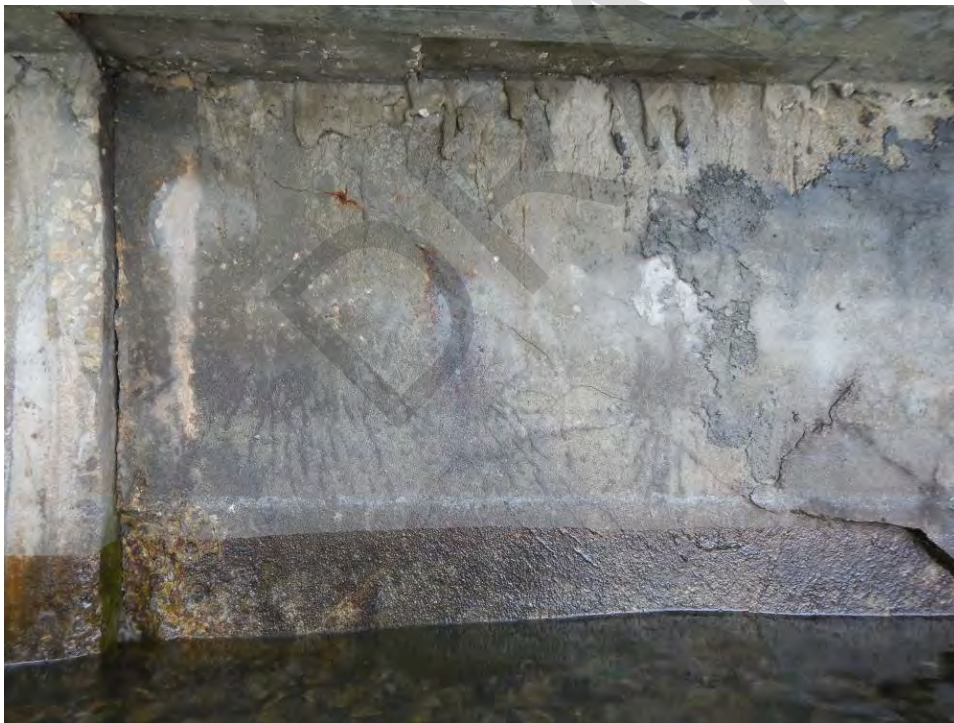
Figure 4-9: Diagonal crack with corrosion staining at the first joint from the bridge on the southeast corner where the wingwall meets the seawall.

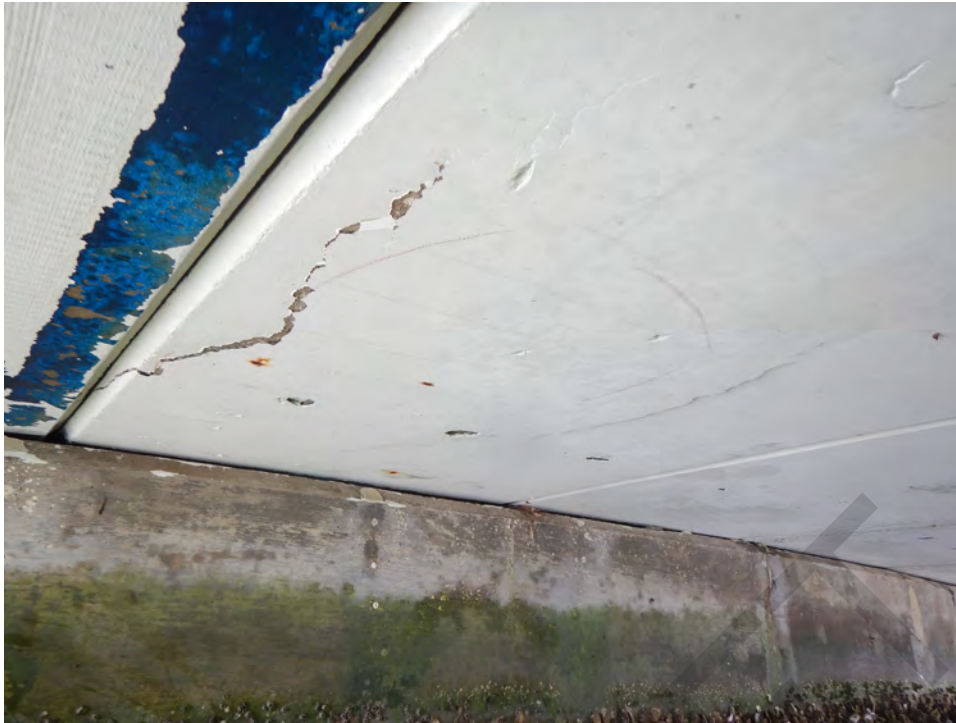
Figure 6-10: Area of delamination on underside of bridge deck.

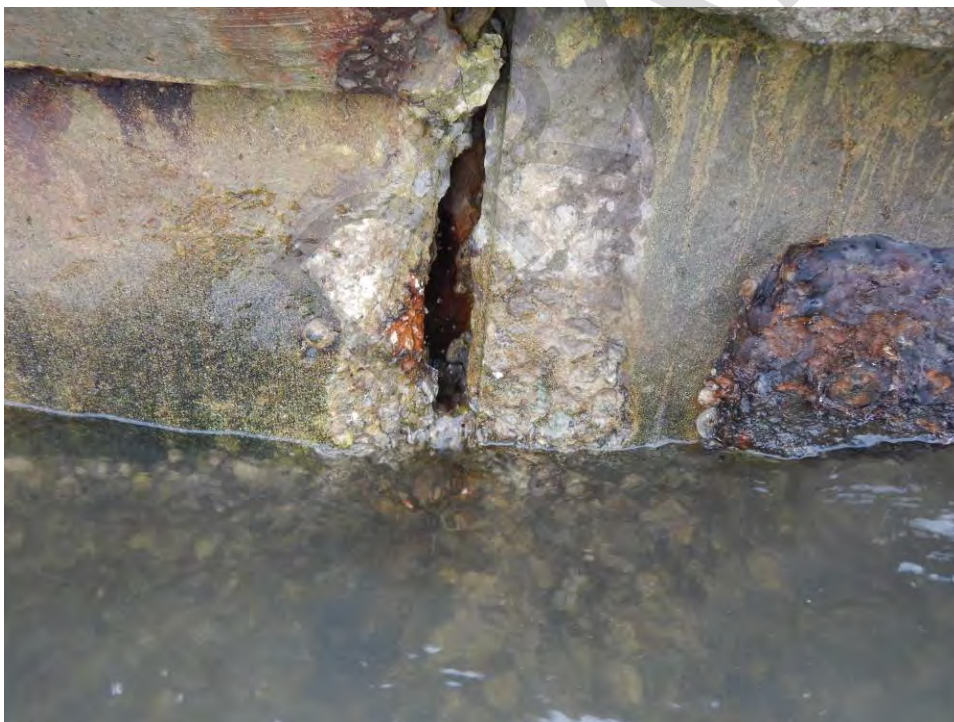
Figure 7-7: Typical spalling at concrete seawall panel joints

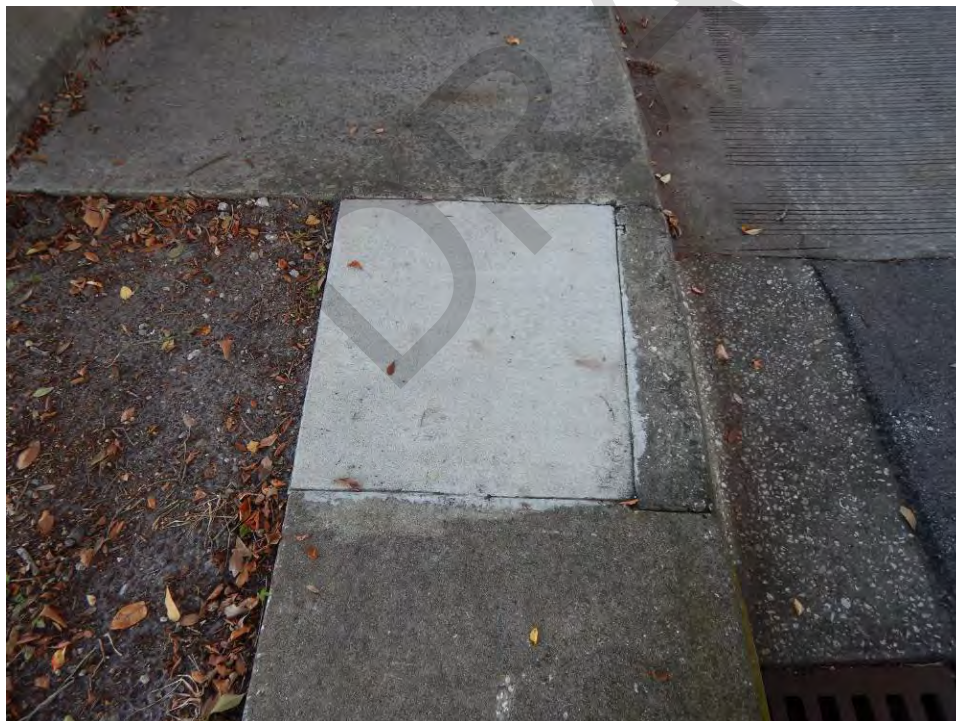
Figure 8-3: Sidewalk repair

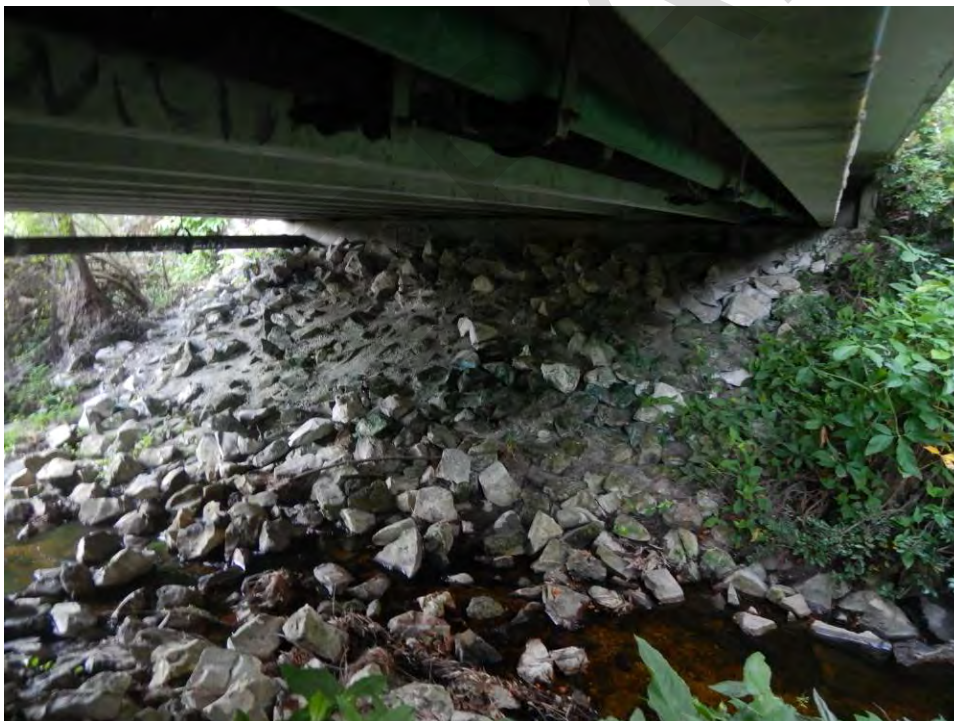
Figure 8-5: Channel and concrete rubble embankments

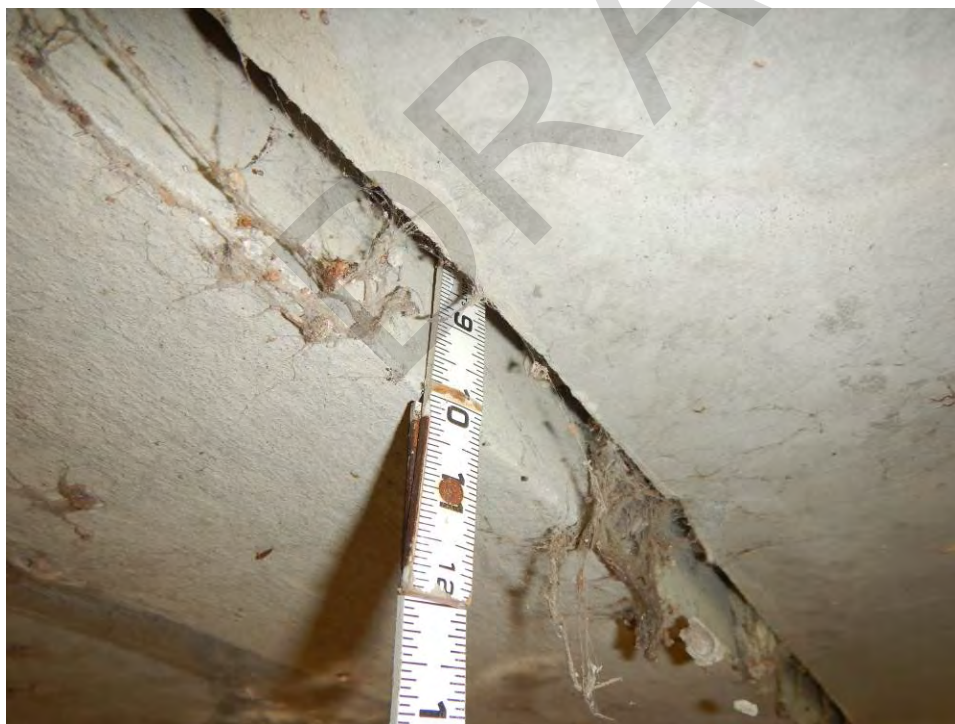
Figure 9-3: Misalignment between culvert segments with up to ten (10) inches of penetration

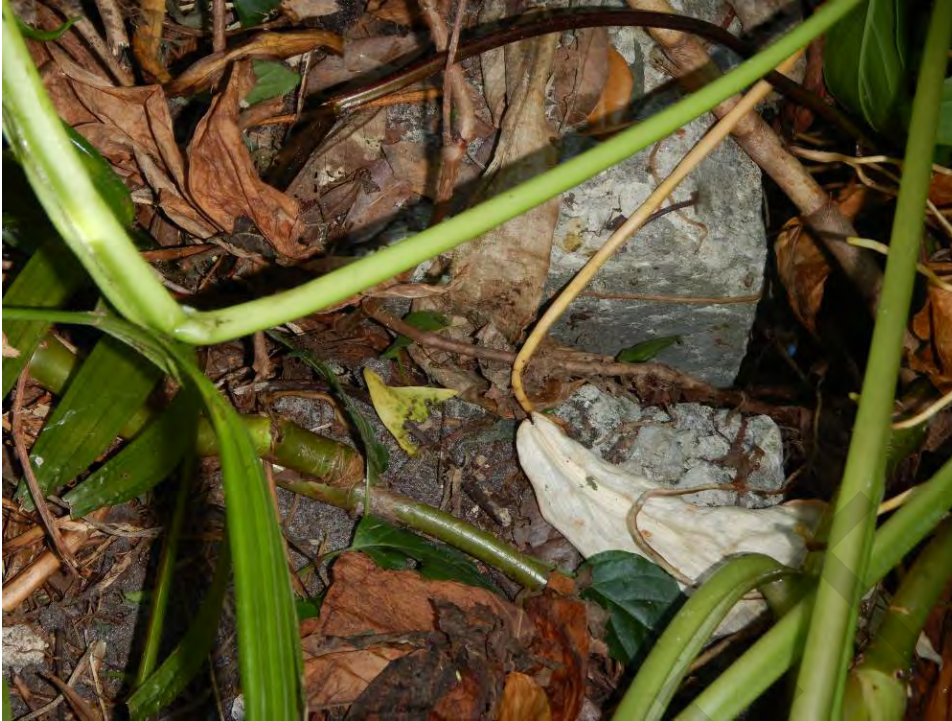
Figure 9-8: Area of settlement and misalignment between headwall and wingwall

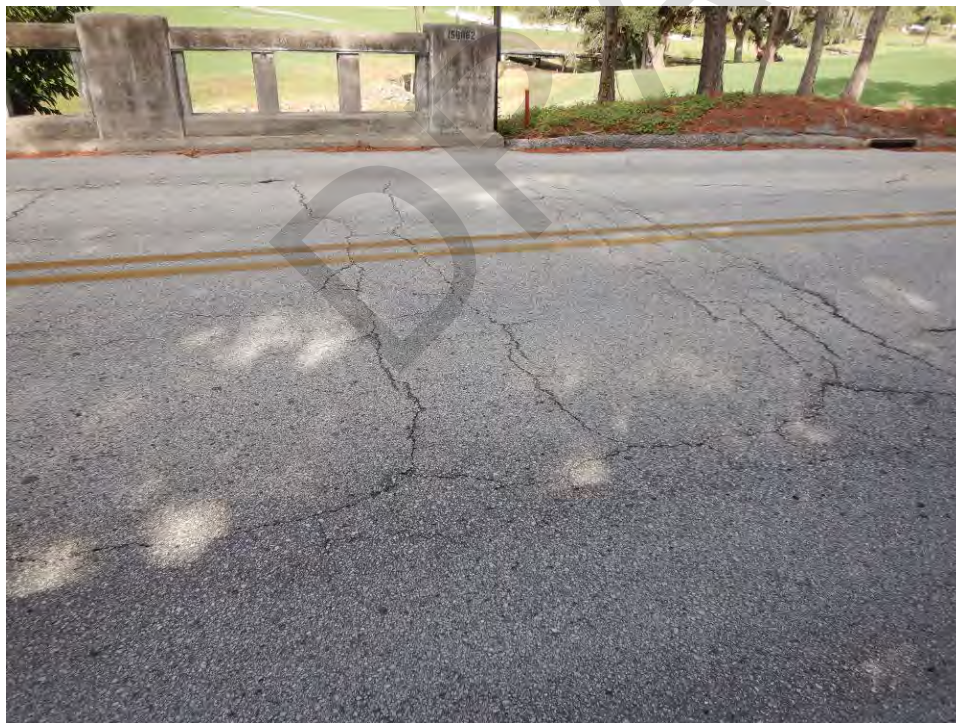
Figure 10-3: Transverse cracks in bridge deck
