Re: **Bridge and Seawall Evaluations**

BRIDGE AND SEAWALL EVALUATIONS

Town of Belleair, FL

January 5, 2021

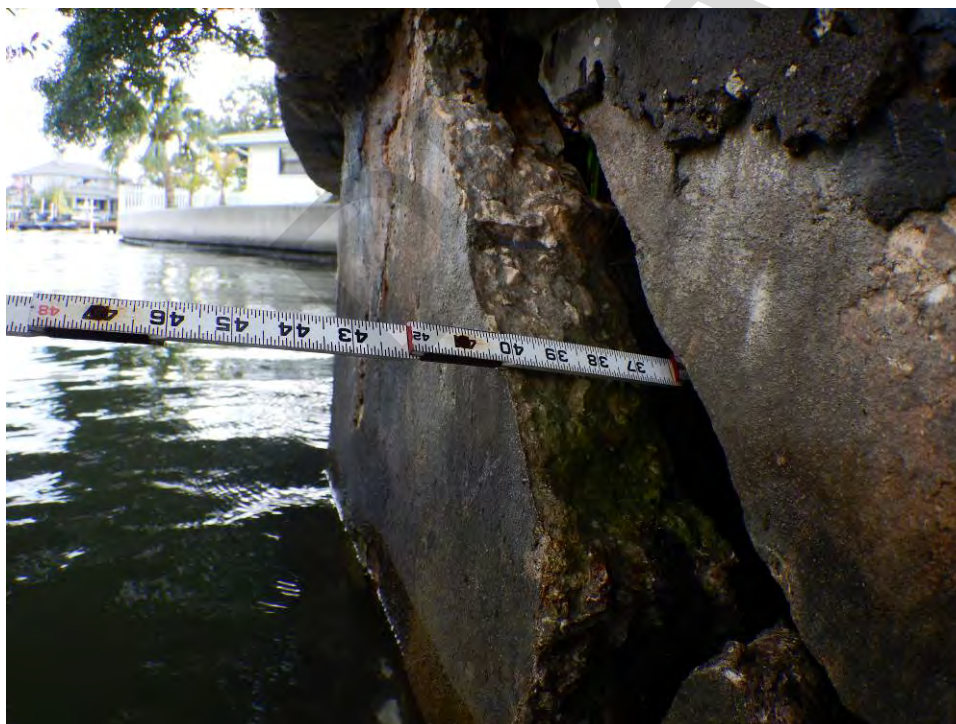
Figure 4-3: Southwest Wall – 4 inches of movement and 36 inch deep void

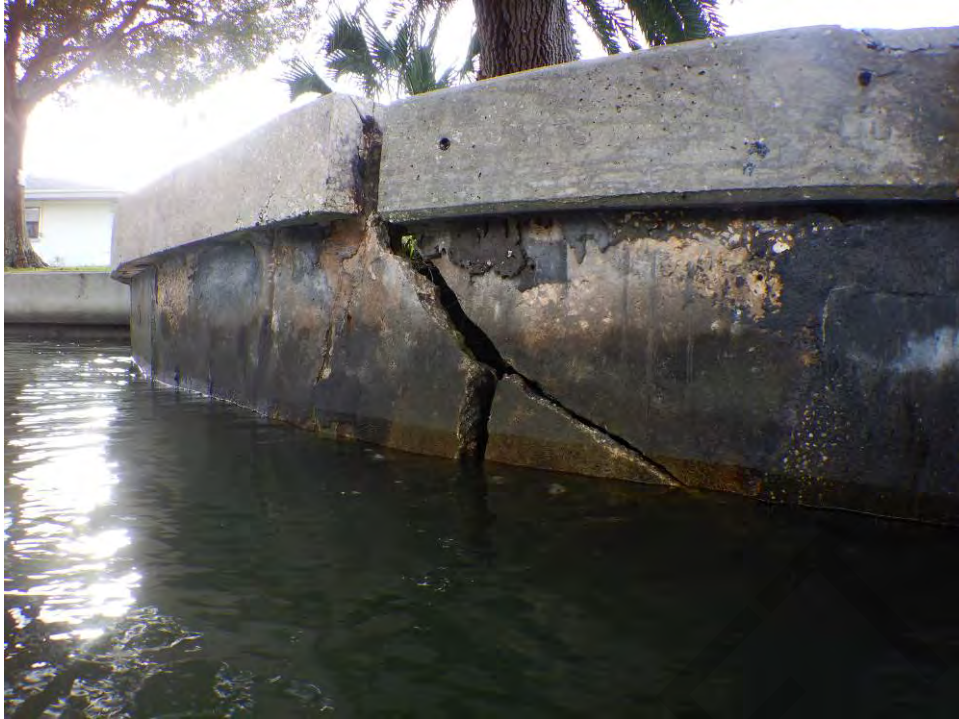
Figure 4-4: Southwest Wall – Opening in the panel and cap with void

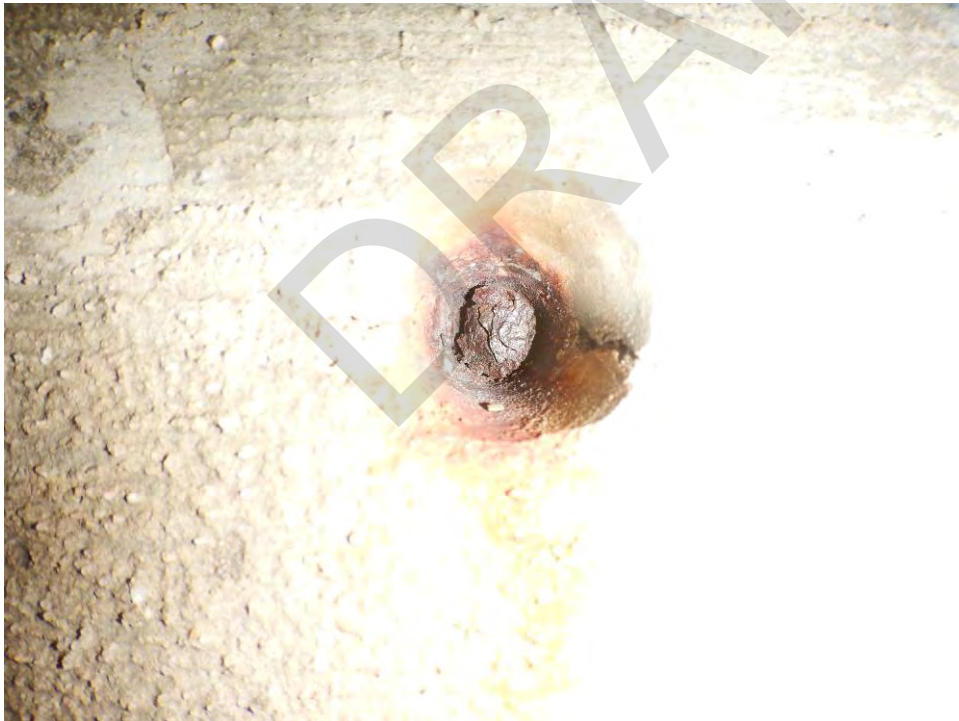
Figure 4-5: Corrosion to steel at unpatched form tie holes in face of abutment

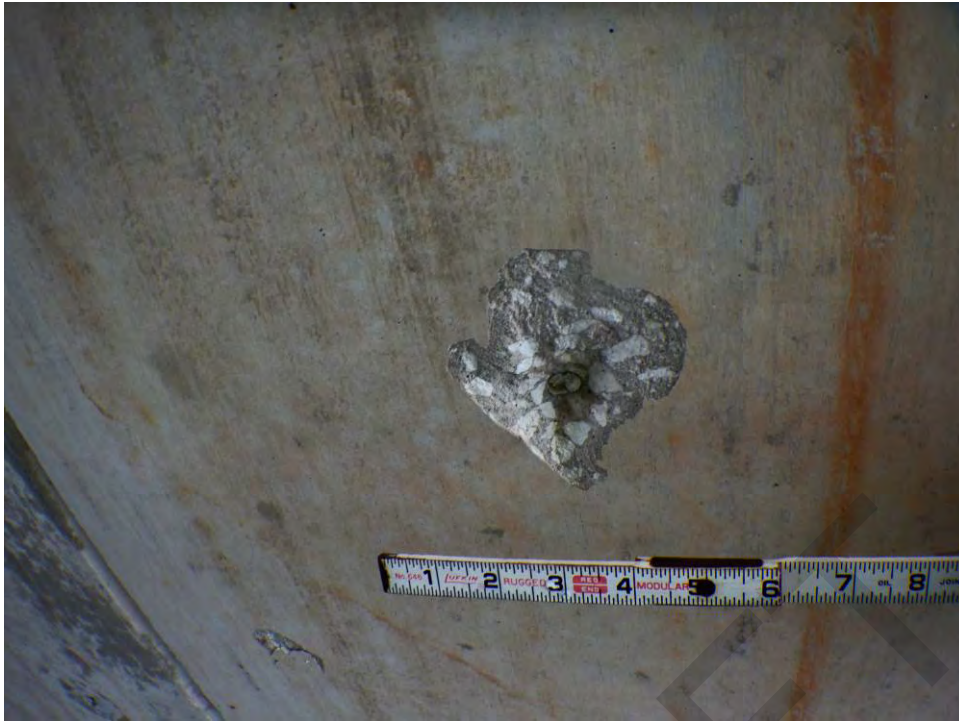
Figure 4-6: Typical spall at the underside of bridge slab beams

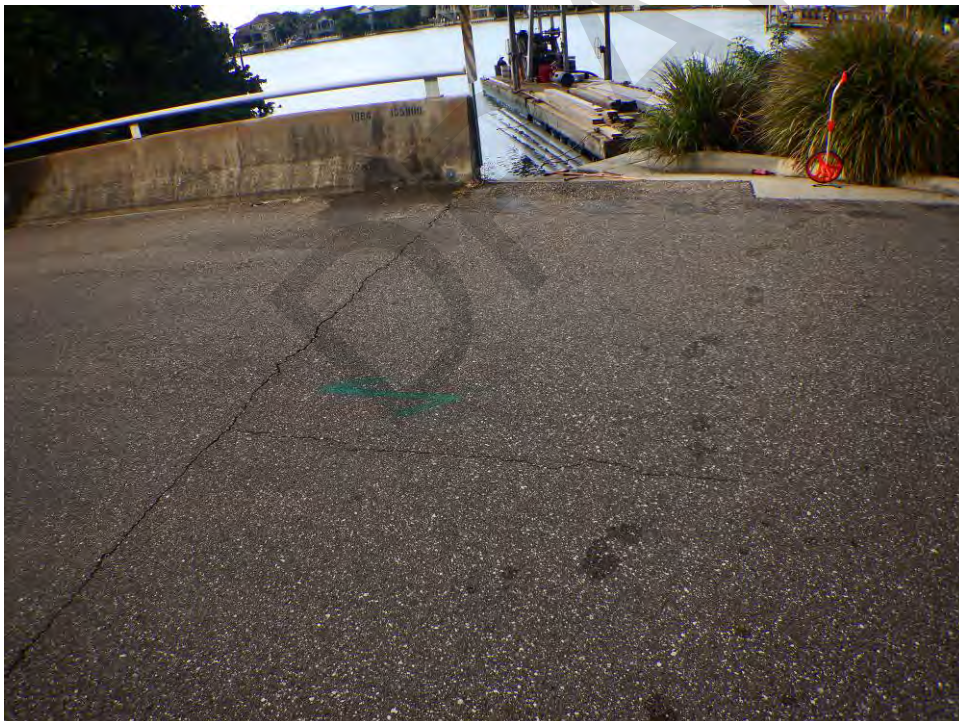
Figure 4-7: Cracks along expansion joint where the approach slab meets the bridge

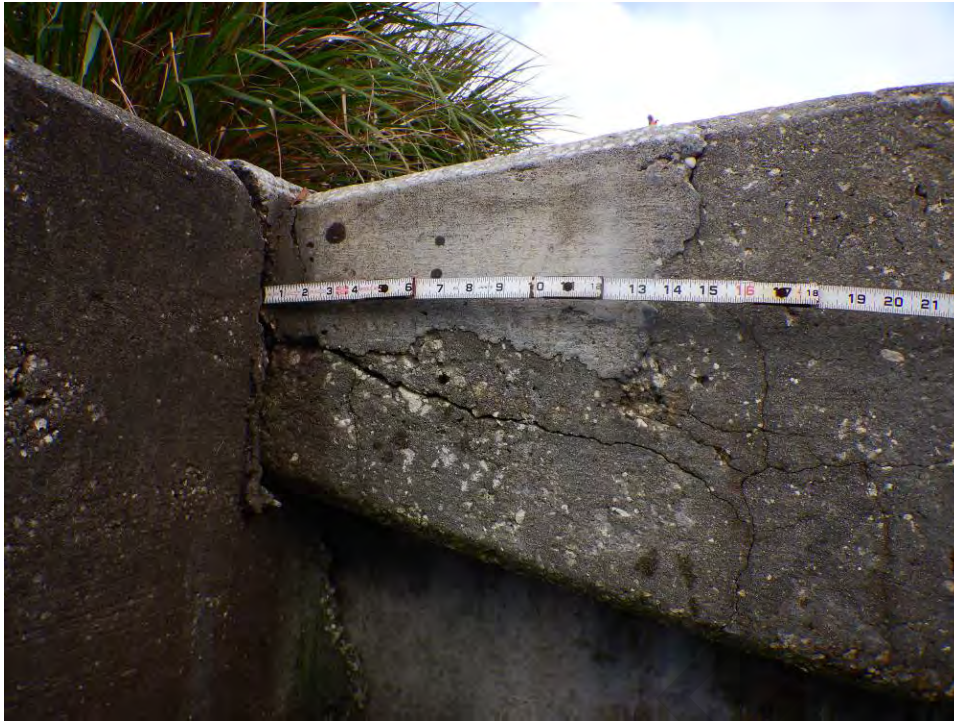
Figure 4-8: Cracks in wingwalls

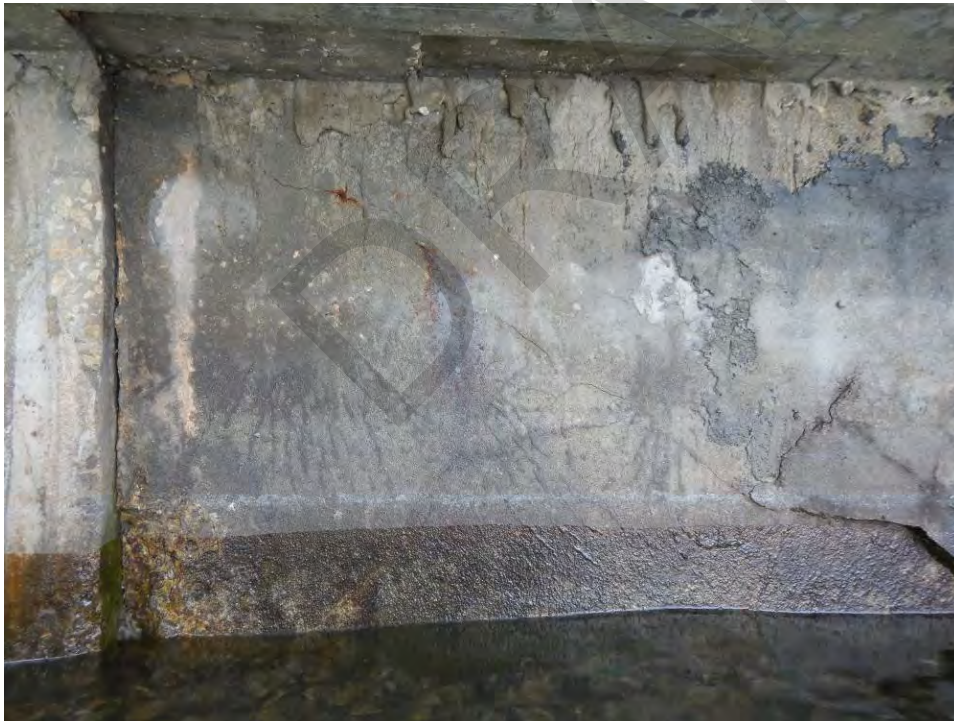
Figure 4-9: Diagonal crack with corrosion staining at the first joint from the bridge on the southeast corner where the wingwall meets the seawall.

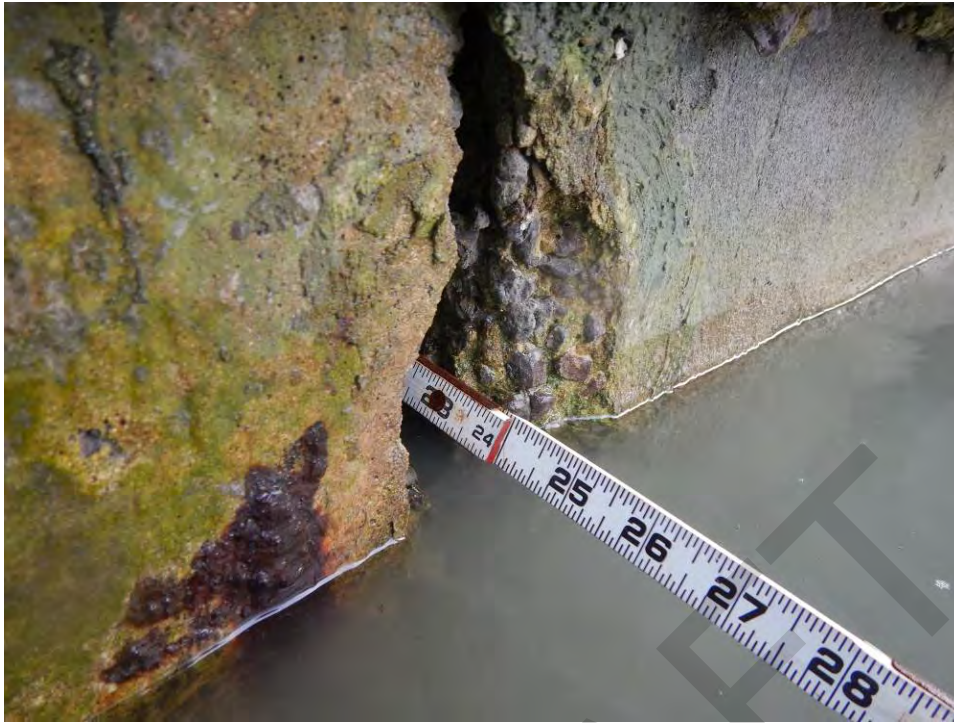
The Winston Park Seawall has a condition assessment rating of SATISFACTORY. There were minor to moderate defects and deterioration observed, but no evidence of overstressing. The concrete cap has been replaced since the installation of the seawall and is in good condition, along with the sidewalks on the upland side of the cap. However, the concrete wall panels are of original construction and have several spalls at the connection joints. One spall located 72 feet from Bridge 155000 has a two-foot-deep

void behind the wall due to backfill loss. None of the spalls were observed to have exposed steel reinforcing.

Figure 5-2: Void behind seawall at wall joint

M&N recommends installing one French Drain behind the seawall where loss of fill was observed. In doing so, future voiding behind the seawall at those locations may be reduced. It is also recommended to fill any voiding with grout to prevent the settlement of the newly poured sidewalk on the upland side of the concrete cap. Per the ASCE Waterfront Inspection Manual, M&N recommends the seawall at Winston Park to be inspected again in 5 years.

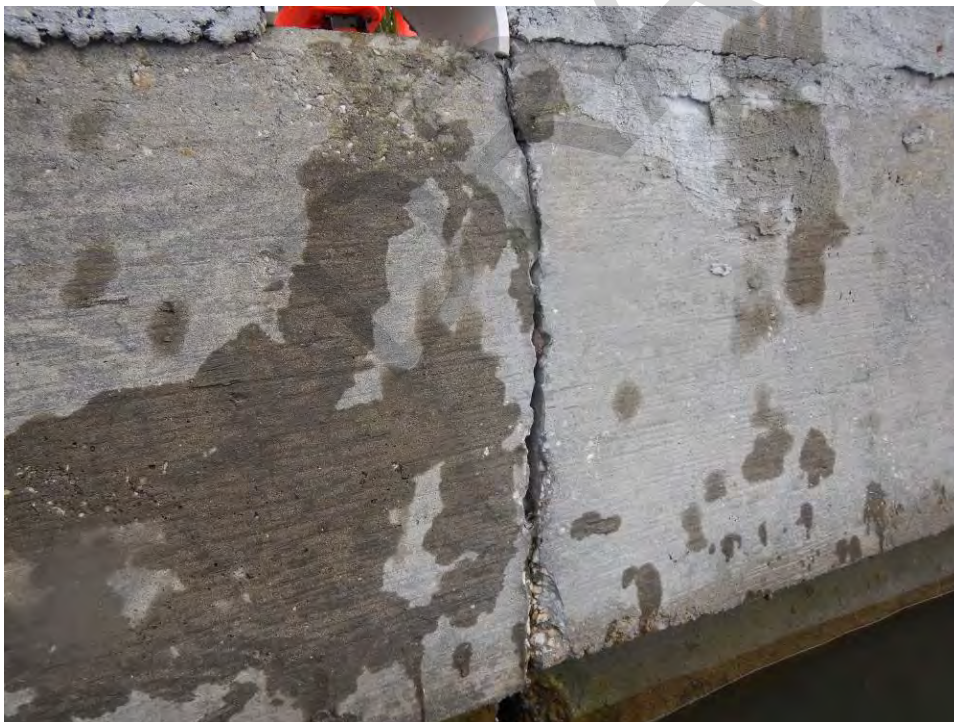
Figure 5-3: Crack in concrete panel cap at wall joint

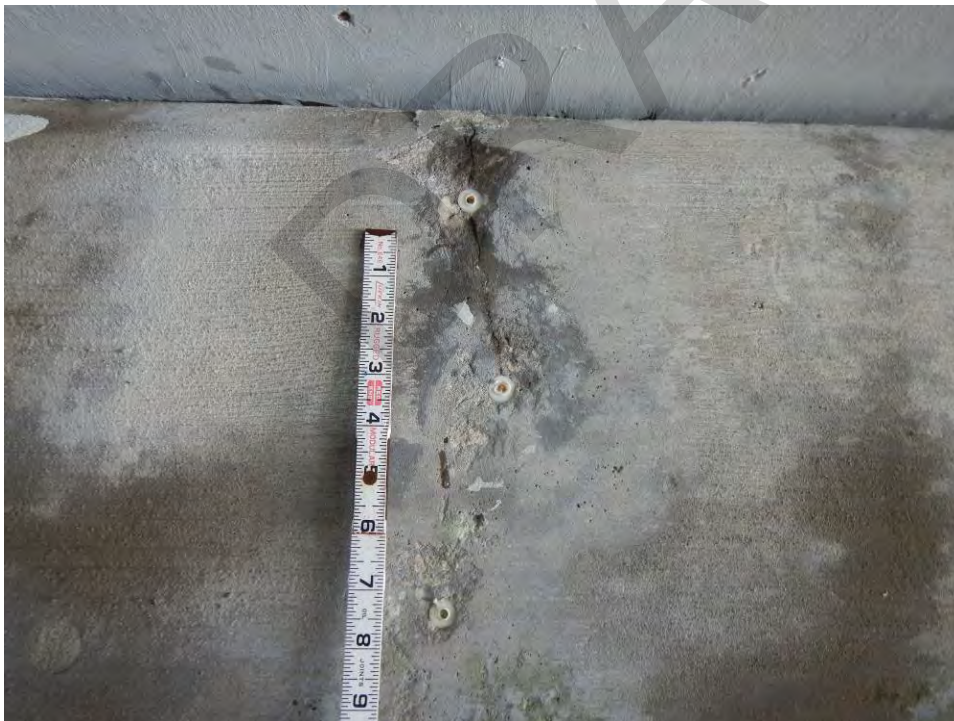
Figure 6-3: Cracks in abutments with epoxy injection repair

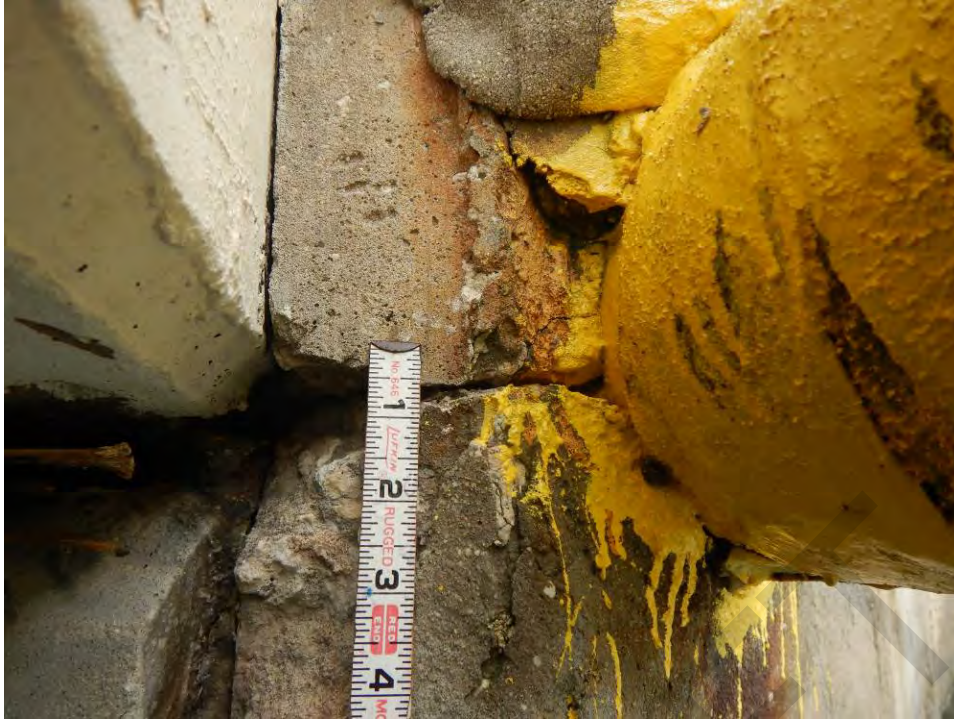
Figure 6-4: Cracks in the southeast wingwall due corroded utility

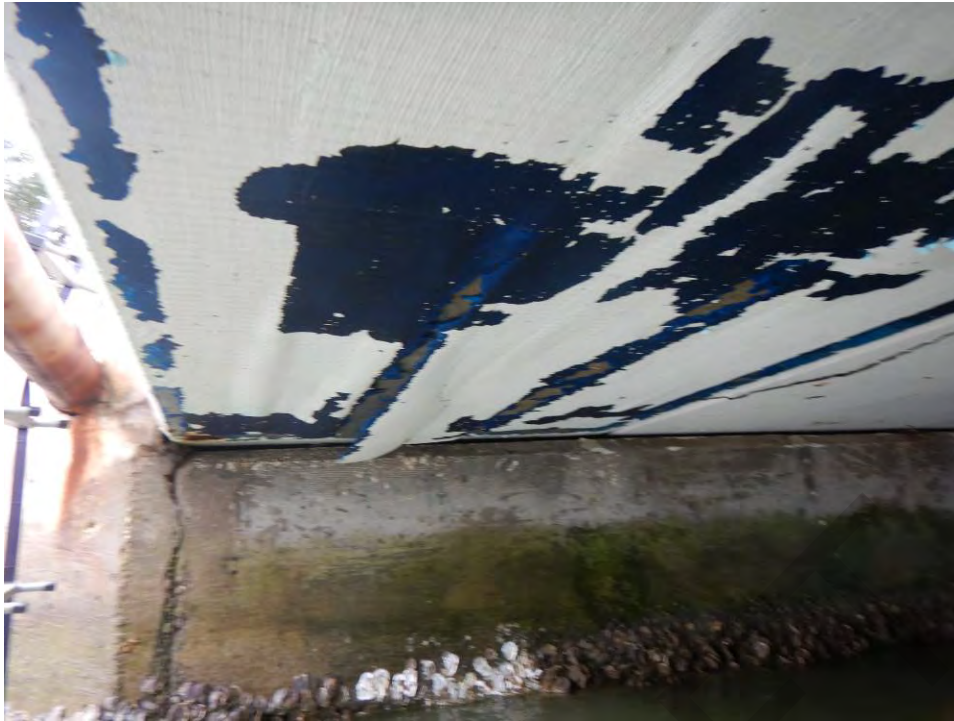
Figure 6-6: Under side coating failure

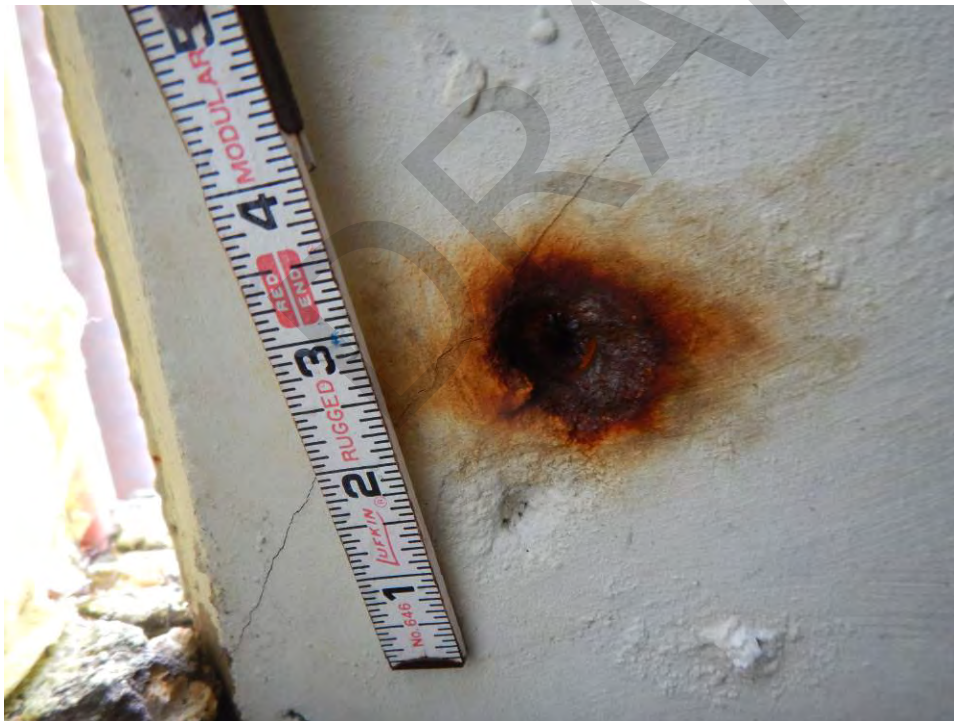
Figure 6-7: Typical random area of corrosion on underside of Beam Slab panels

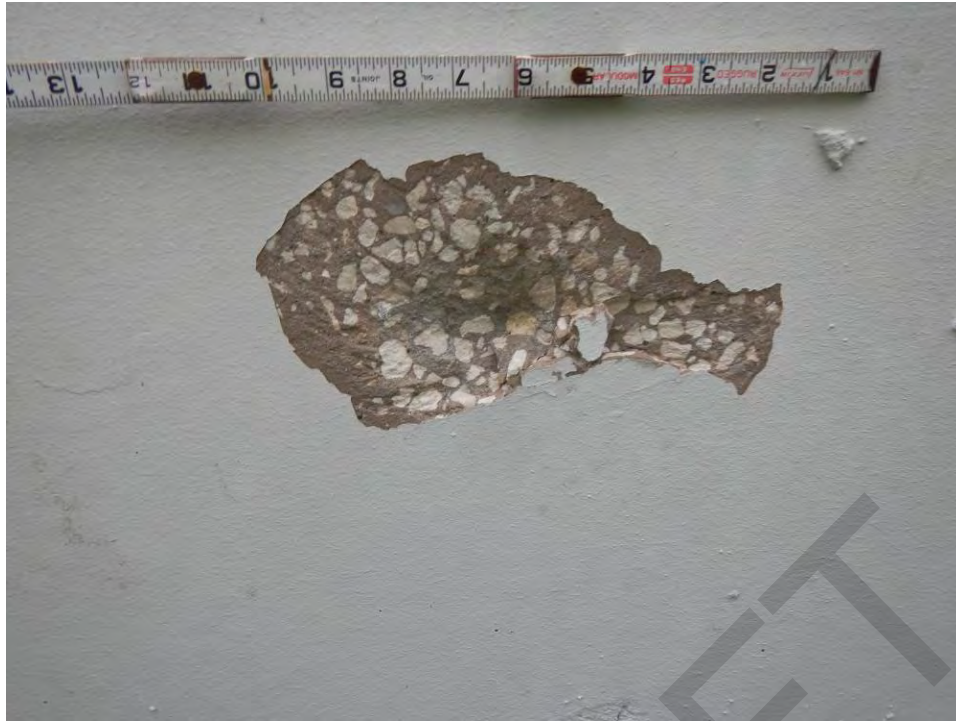
Figure 6-8: Typical spall in underside of Beam Slab panels

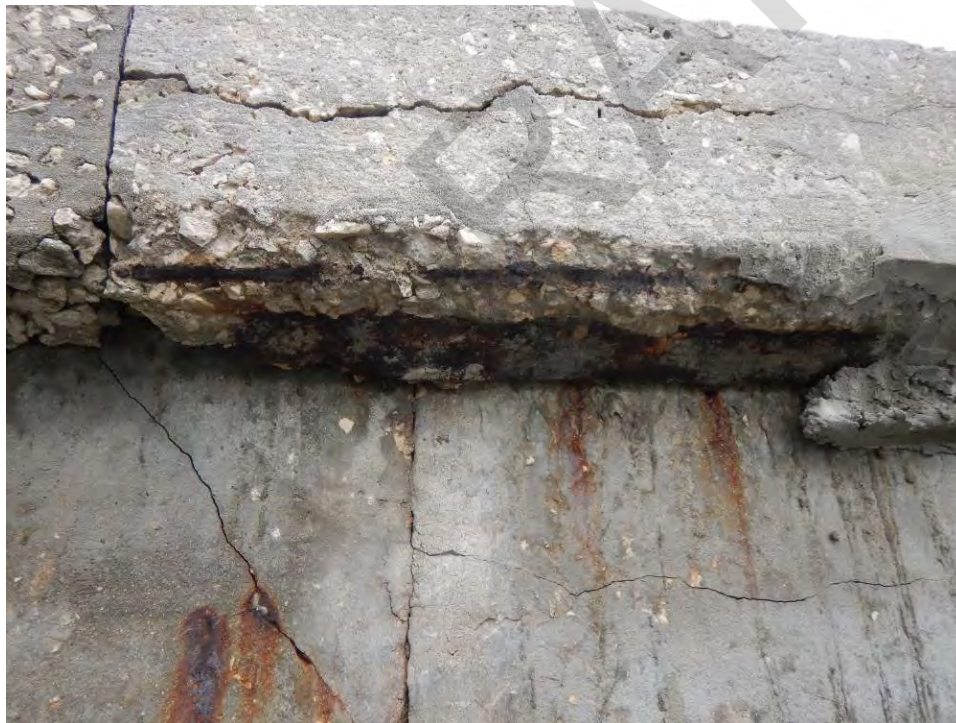
Figure 6-9: Cracks in wingwall / concrete panel wall connection on the southeast side of bridge. There is failure of the cap here with exposed steel reinforcing.

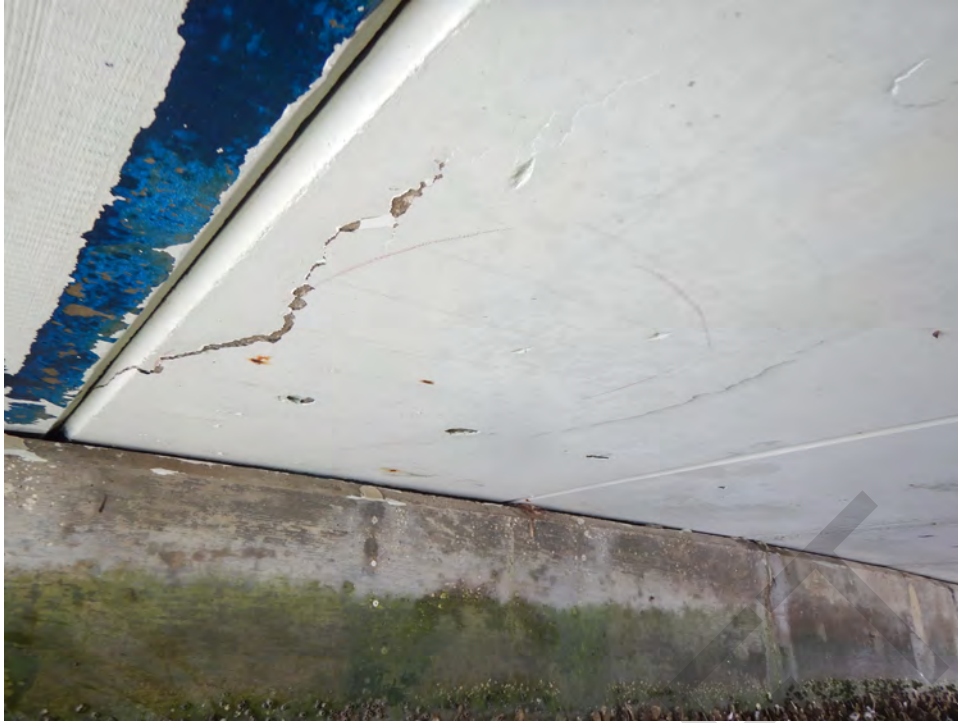
Figure 6-10: Area of delamination on underside of bridge deck.

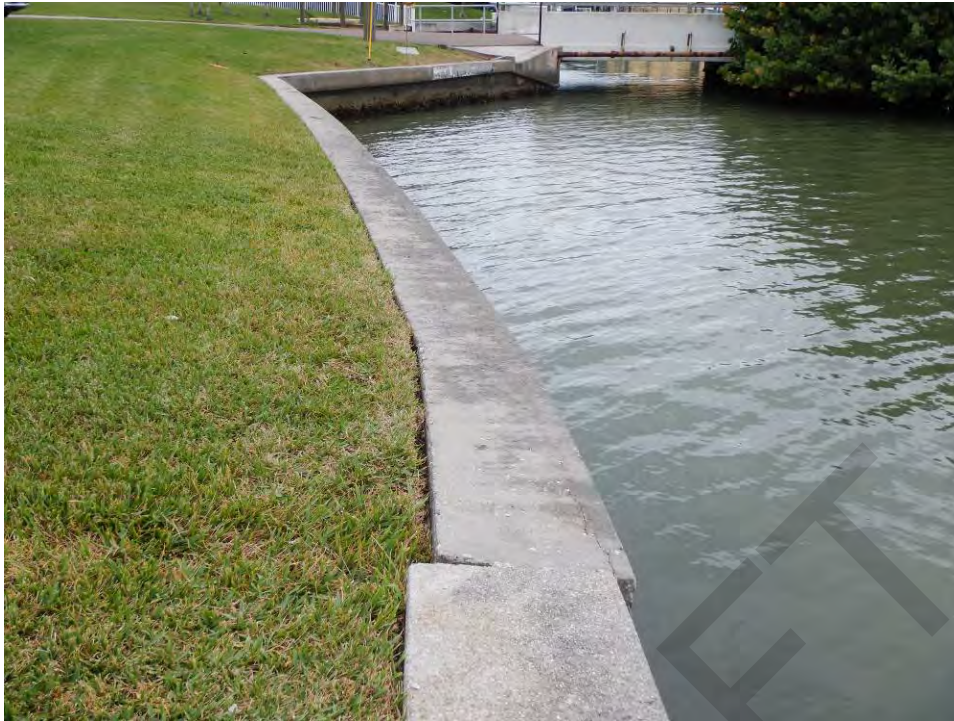
The Thompson Park Seawall has a condition assessment rating of SERIOUS. There are various areas of backfill loss with voiding behind the seawall along its entire length. These areas mostly occur at the concrete panel joints that have spalled and opened. Additionally, there is a 50-foot section of wall with up to six inches of lateral movement which has resulted in a large void and backfill loss. Additionally, there are a multitude of full-height cracks in the concrete cap and panels, along with spalls at every panel joint. The tie-rods here are all exposed and have coating failure with flaking corrosion, and one tie-rod 22 feet from the bridge has failed.

Figure 7-2 Wall failure resulting in large deflection between wall panels

M&N recommends replacing the Thompson Park Seawall on a moderate-priority basis. Until the seawall is replaced, M&N recommends that vehicular live loading be restricted along the seawall, and that the wall be regularly monitored for additional lateral movement.

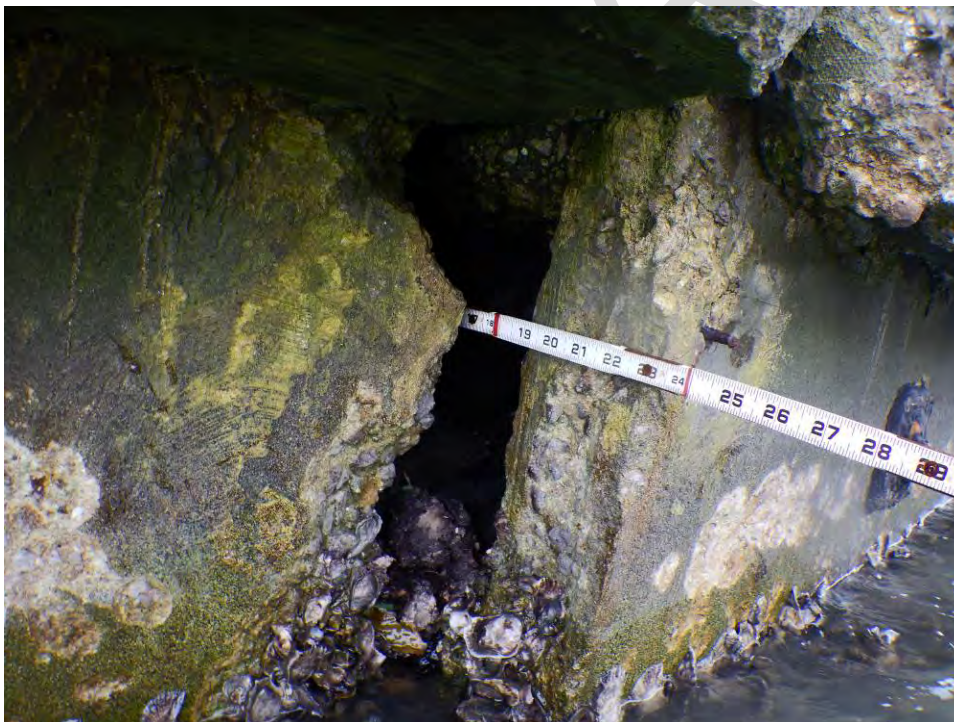
Figure 7-3 Deep void and loss of fill at wall failure

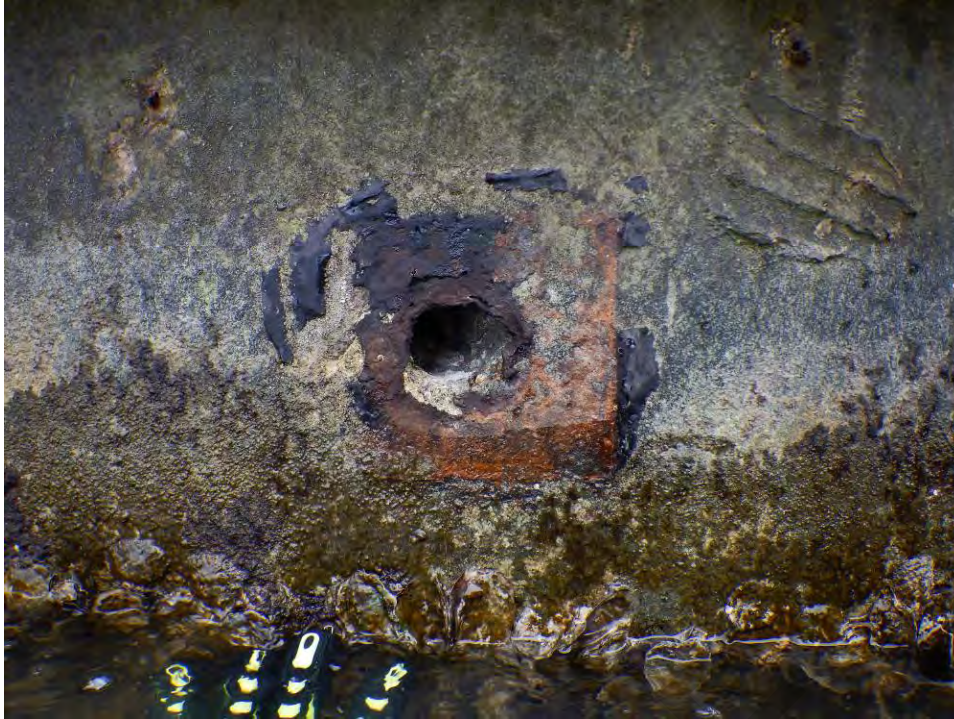
Figure 7-4: Missing tieback hardware

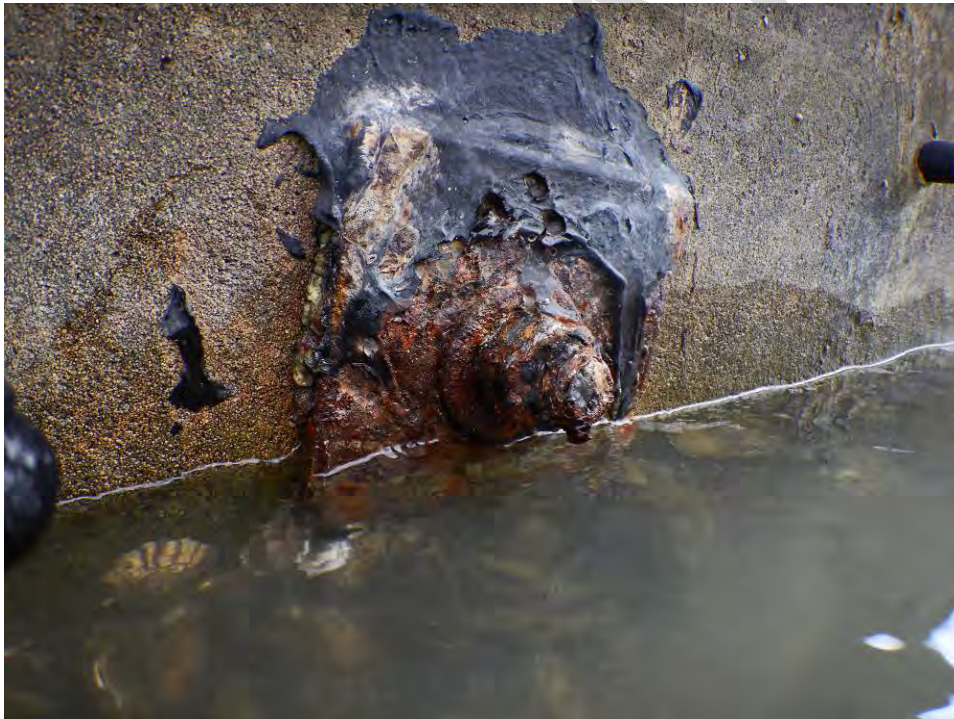
Figure 7-5: Typical tieback hardware, heavily corroded

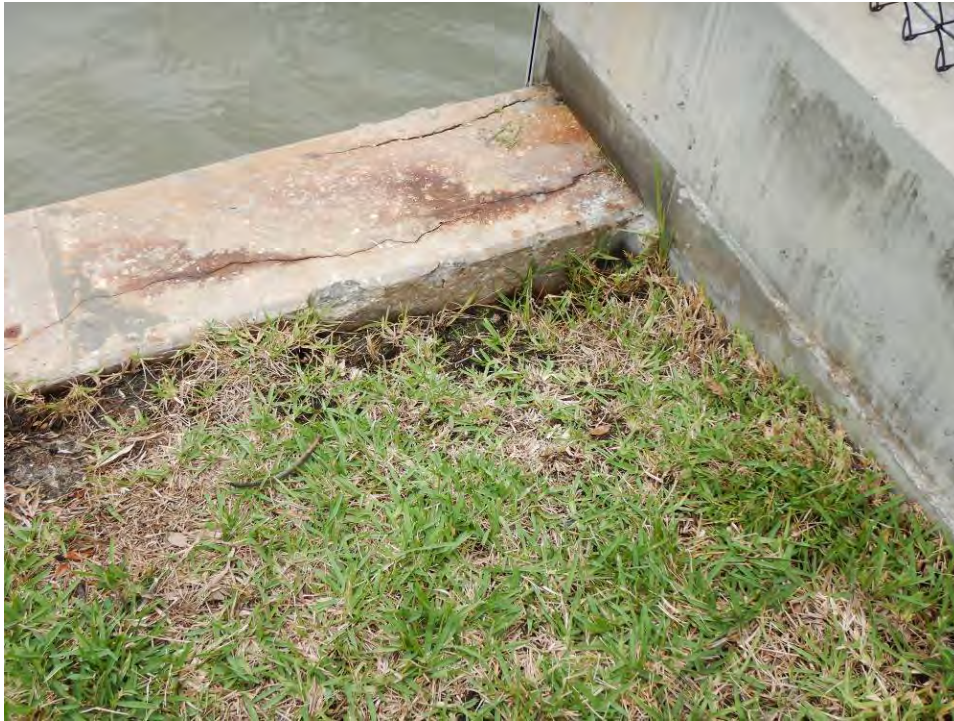
Figure 7-6 Evidence of fill loss behind seawall cap and longitudinal cracks with corrosion staining in top of concrete cap.

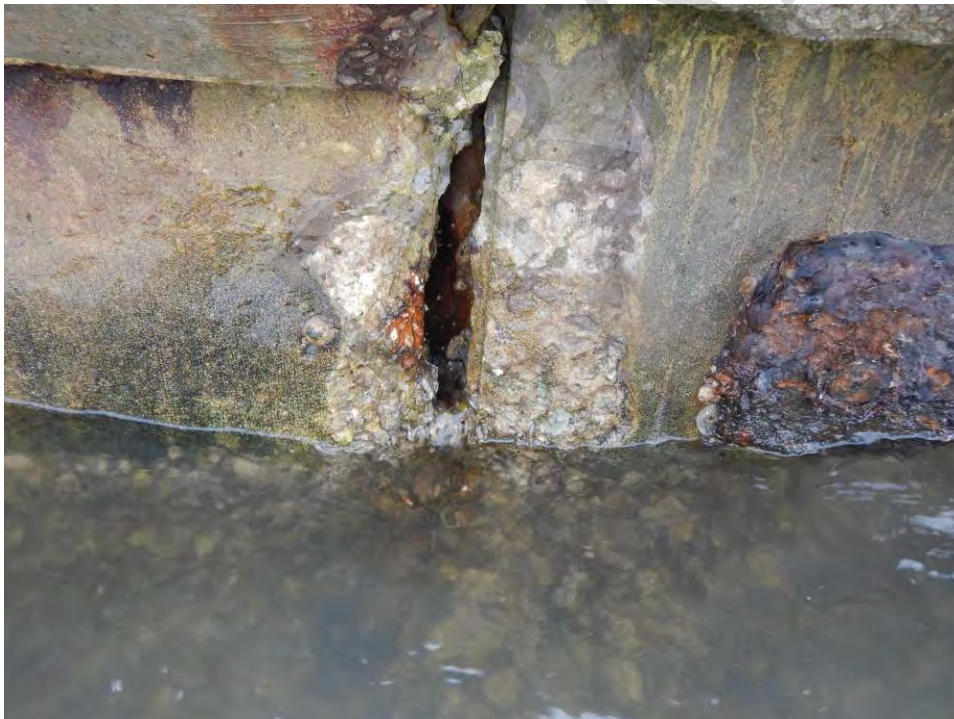
Figure 7-7: Typical spalling at concrete seawall panel joints

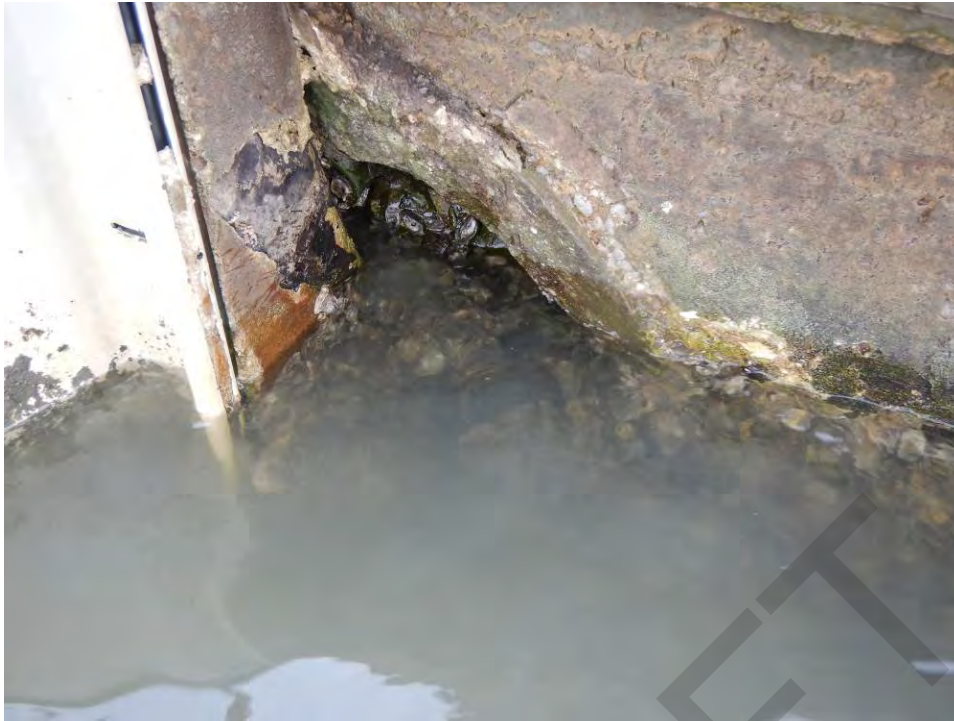
Figure 7-8: Partially covered outfall at the private property line north of the park

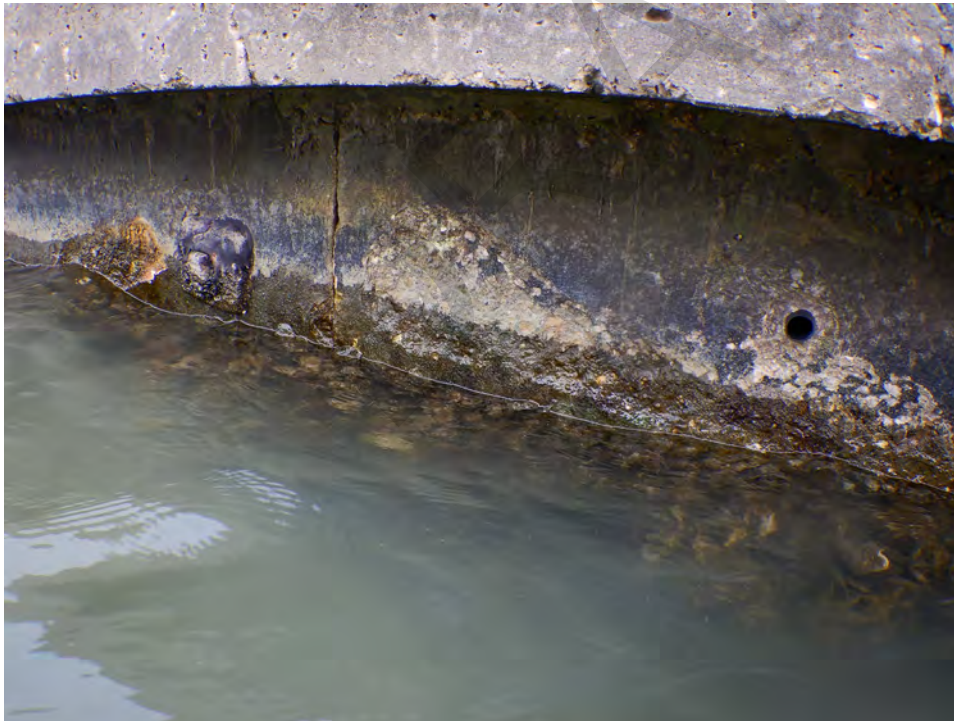
Figure 7-9: Example area of abrasion along seawall in splash zone

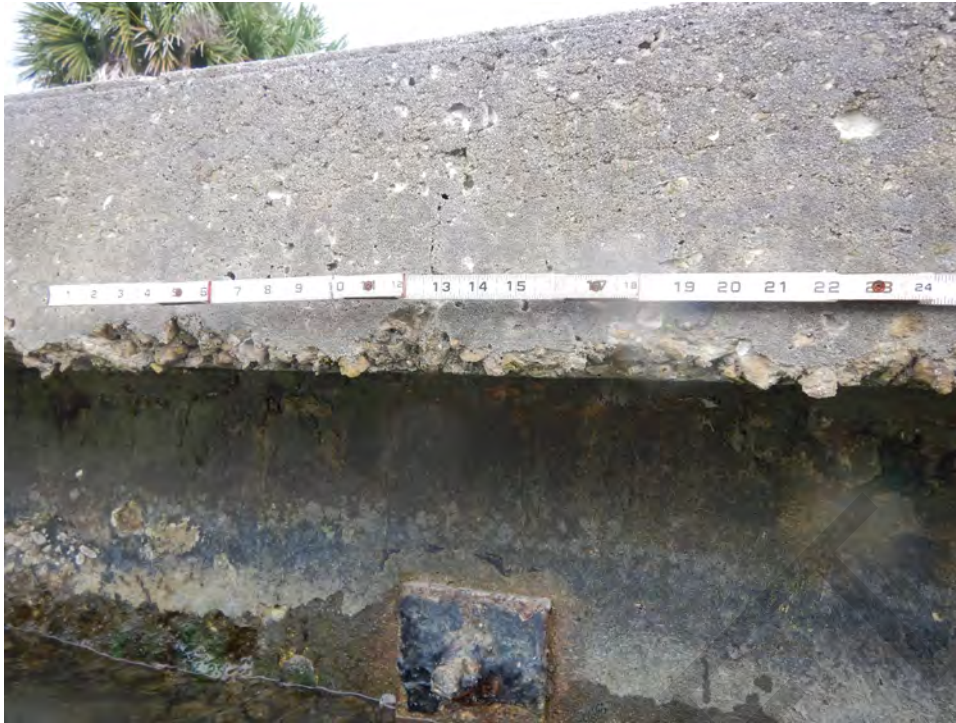
Figure 7-10: Typical spalling and cracking of cap underside

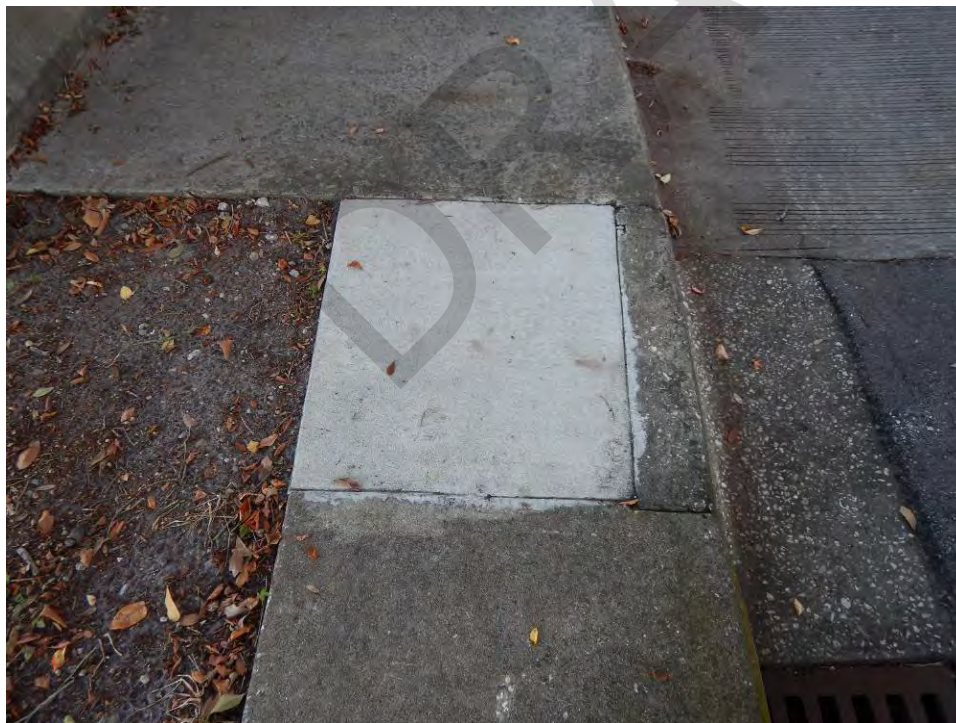
Figure 8-3: Sidewalk repair

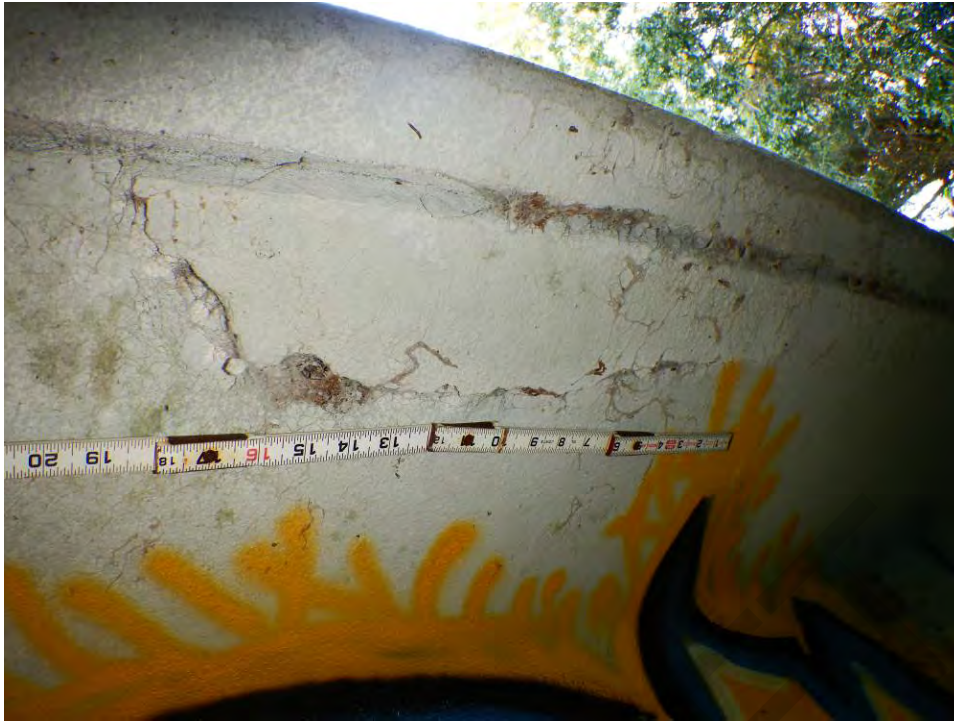
Figure 8-4: Area of delamination in beam

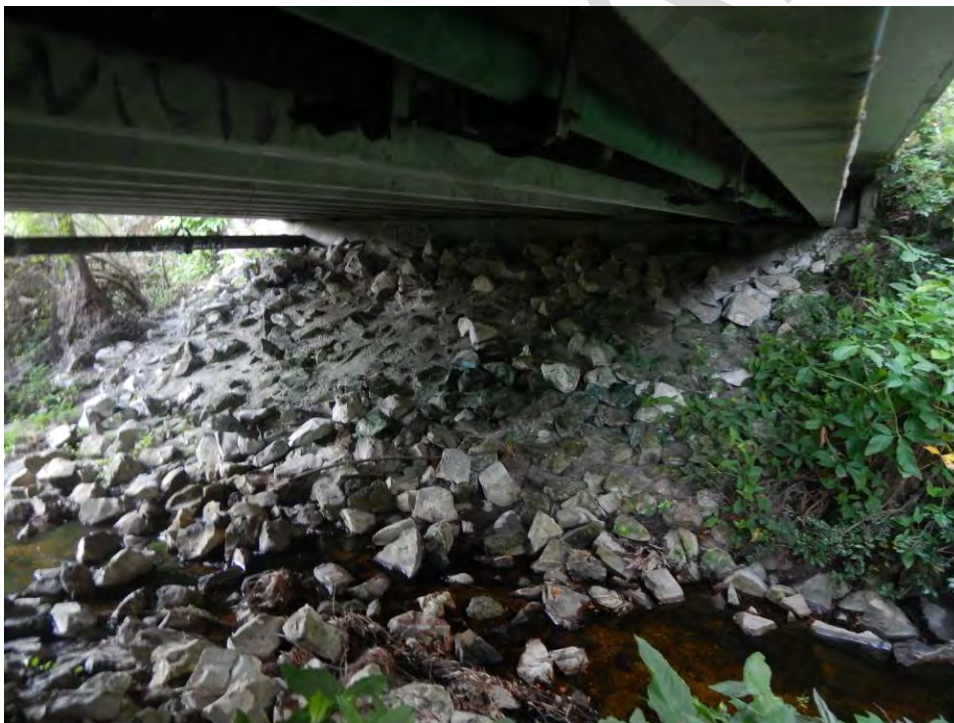
Figure 8-5: Channel and concrete rubble embankments

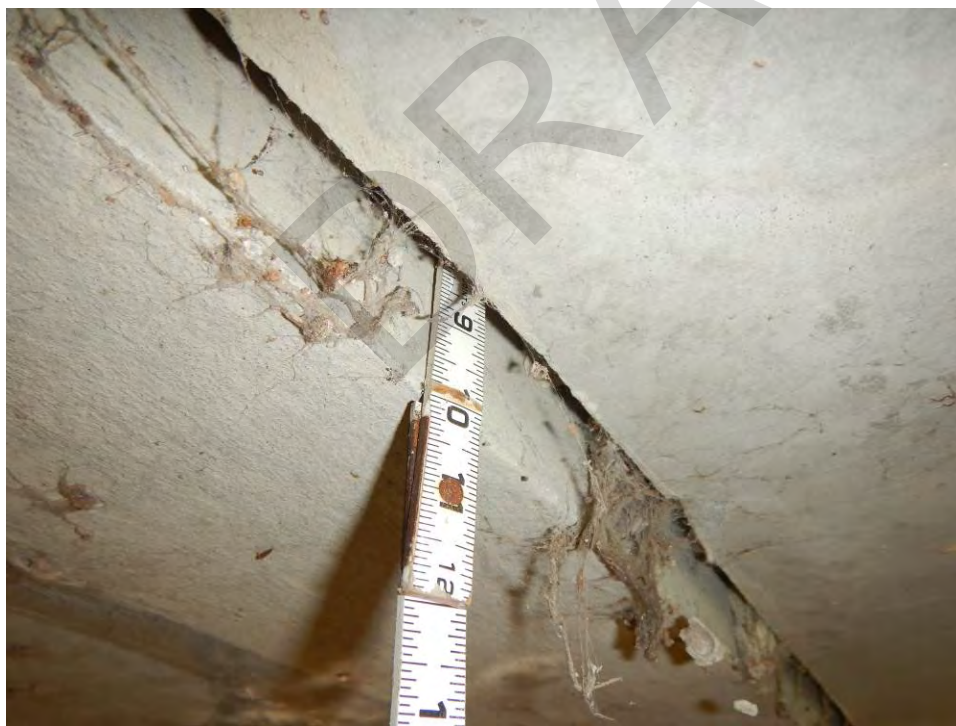
Figure 9-3: Misalignment between culvert segments with up to ten (10) inches of penetration

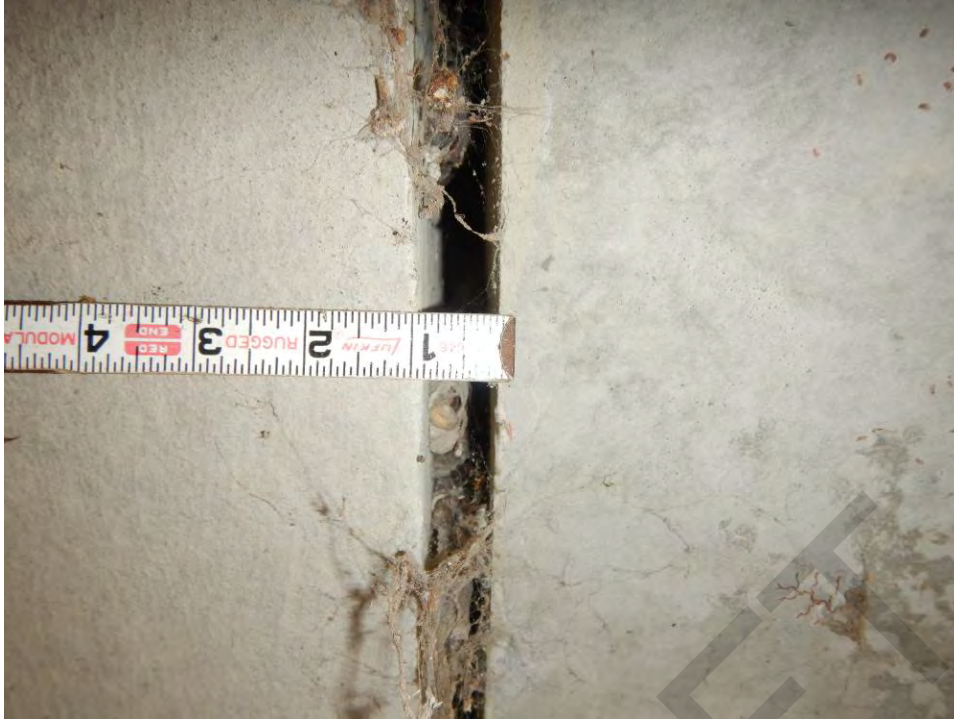
Figure 9-4: Opening between culvert segments

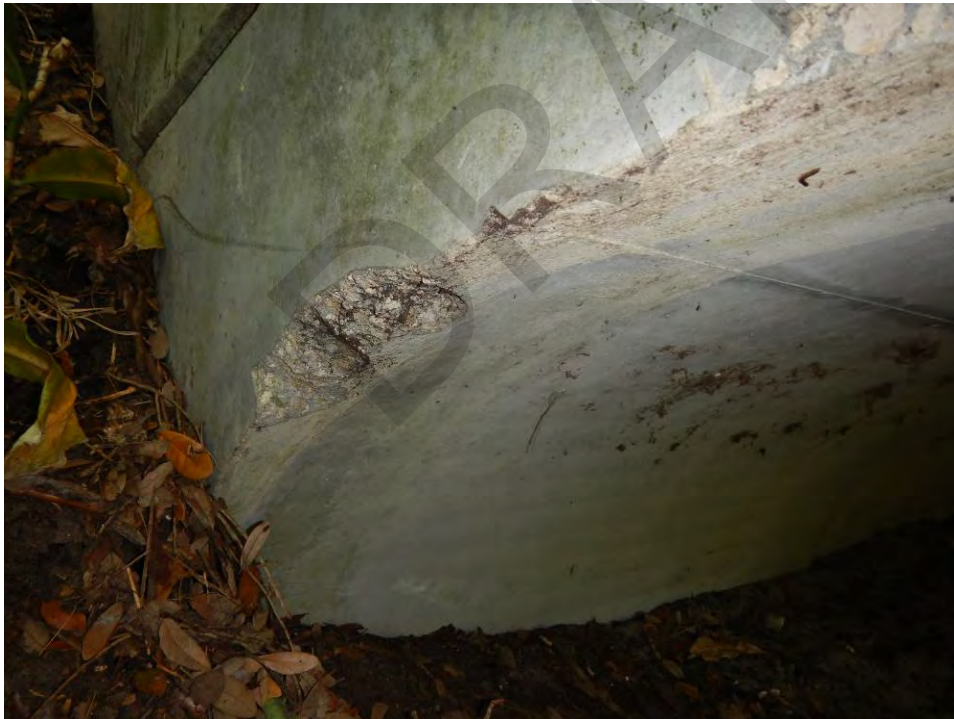
Figure 9-5: Construction spalling along ceiling edge of culvert opening

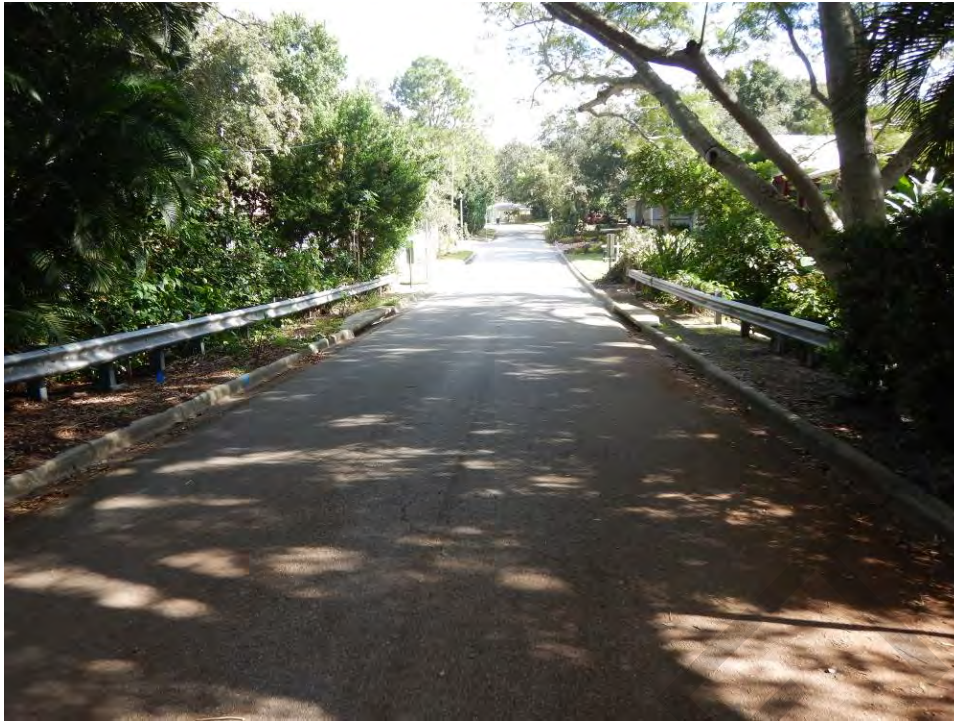
Figure 9-6: Bridge section & overgrown vegetation
