Re: **Bridge and Seawall Evaluations**

BRIDGE AND SEAWALL EVALUATIONS

Town of Belleair, FL

January 5, 2021

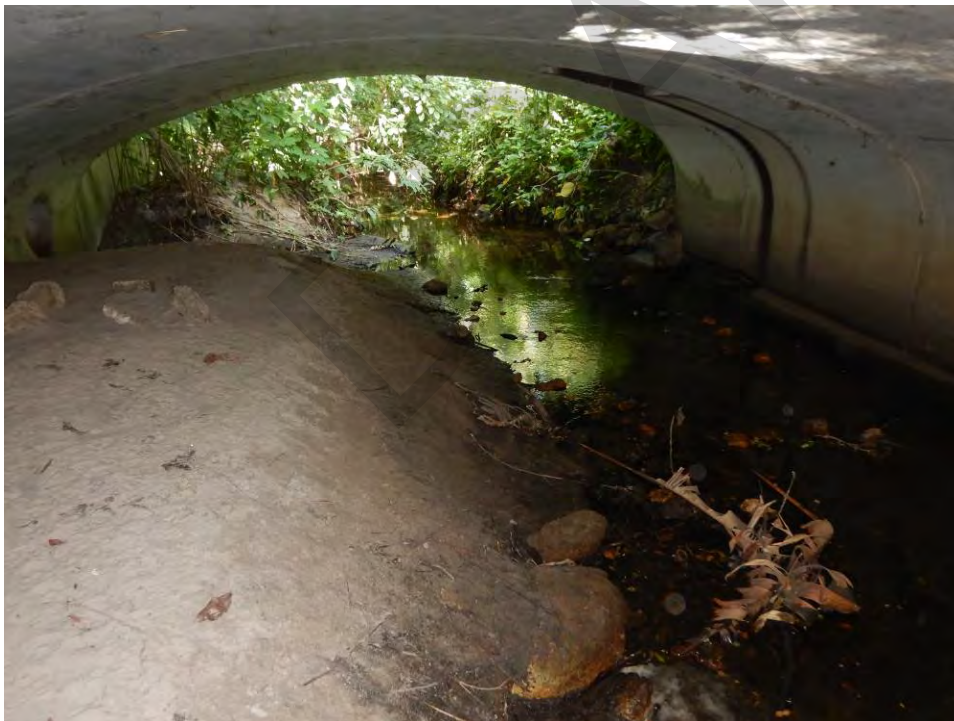
Figure 9-7: Aggradation within culvert

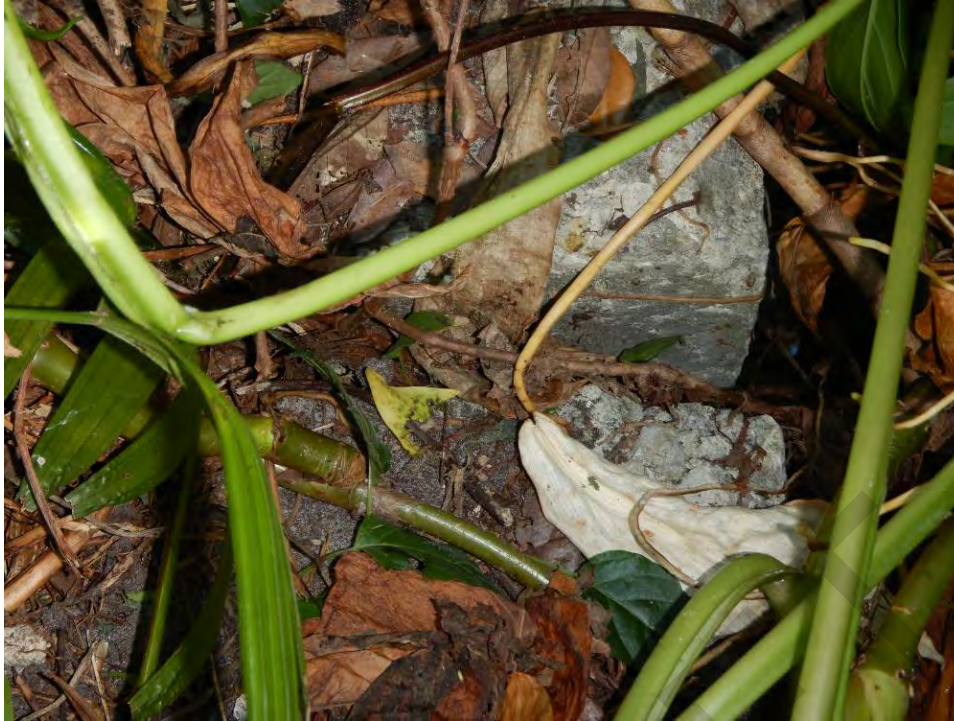
Figure 9-8: Area of settlement and misalignment between headwall and wingwall

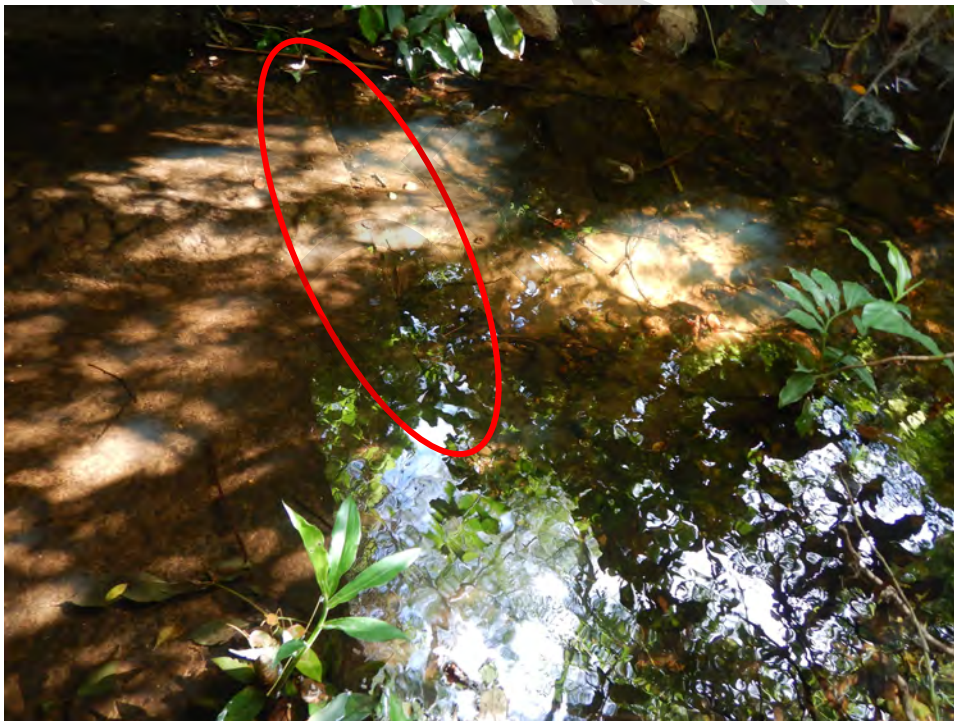
Figure 9-9: Example of exposed toe on the upstream side of the structure

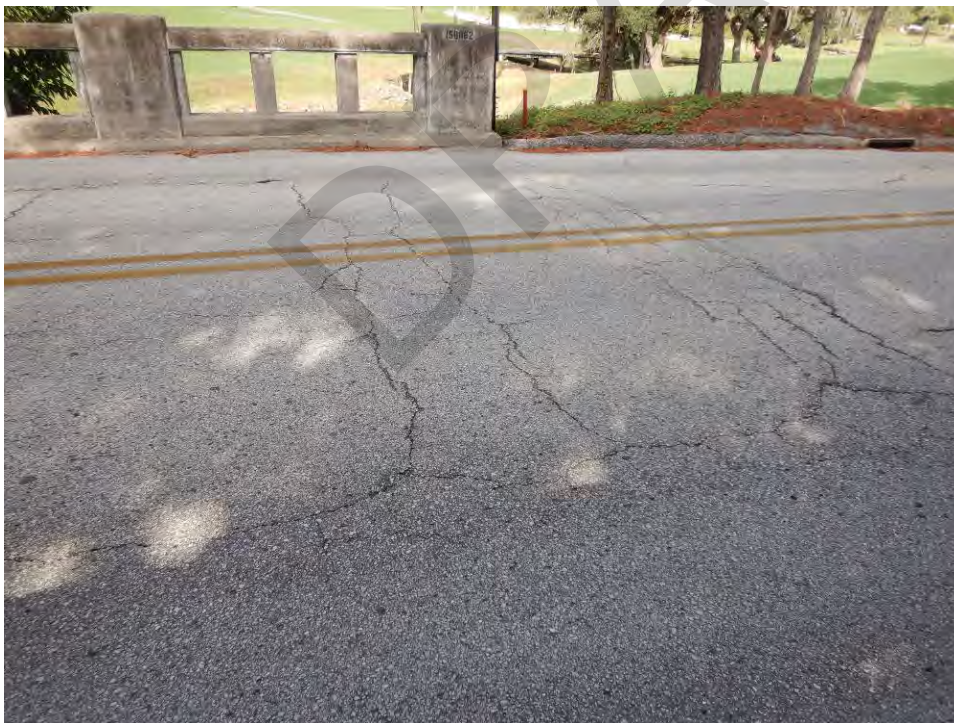
Figure 10-3: Transverse cracks in bridge deck

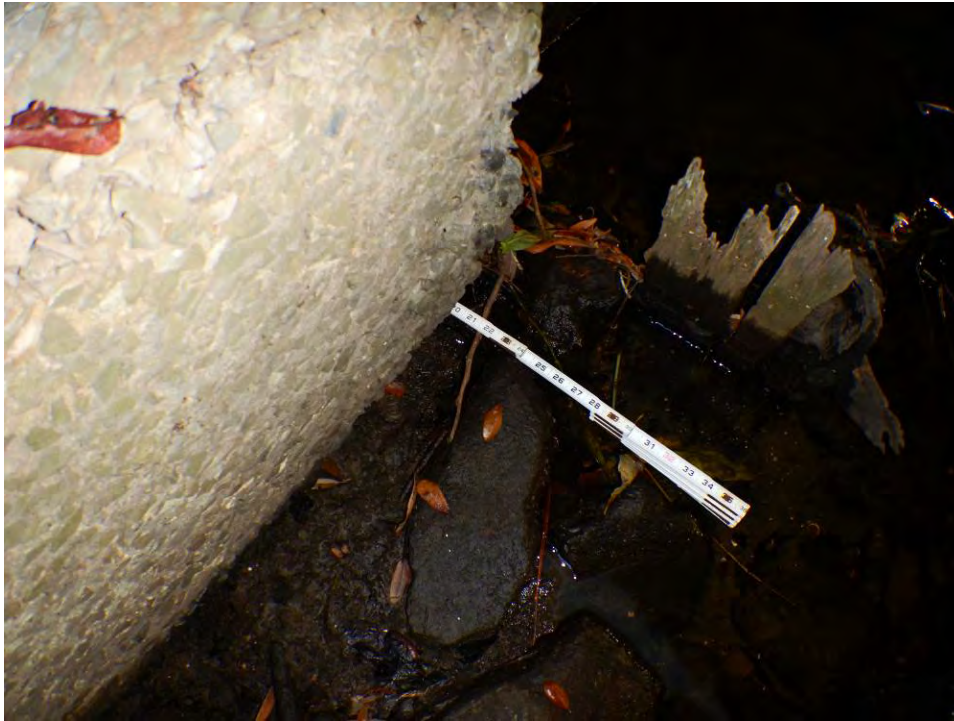
Figure 10-4: Undermining at northwest wingwall three (3) inches in height with up to two (2) feet of penetration

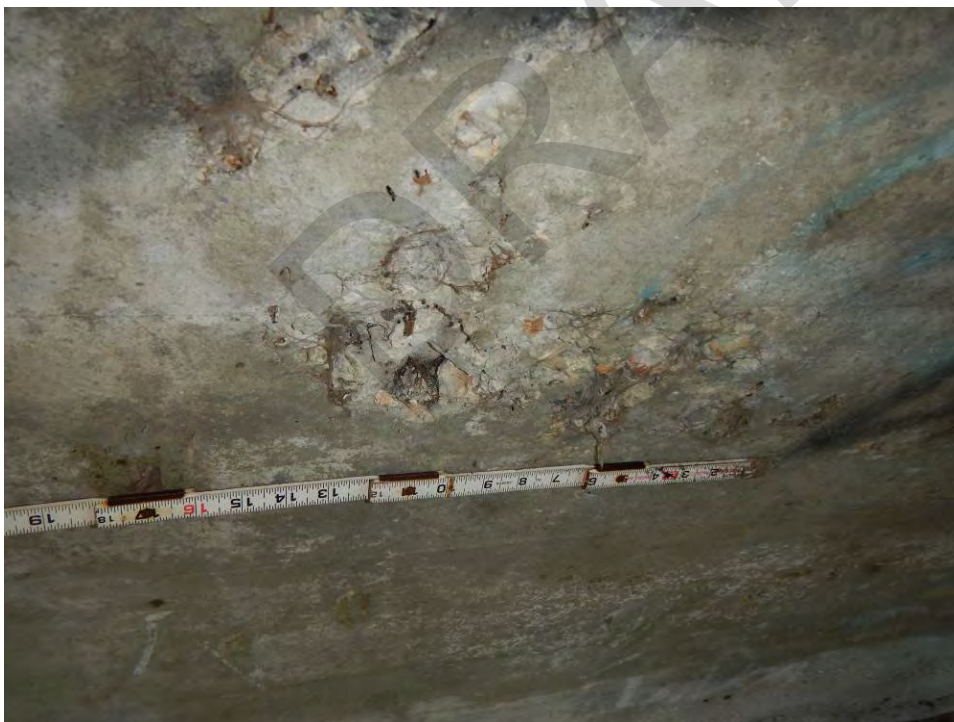
Figure 10-5: Honeycombing under arch near the mudline

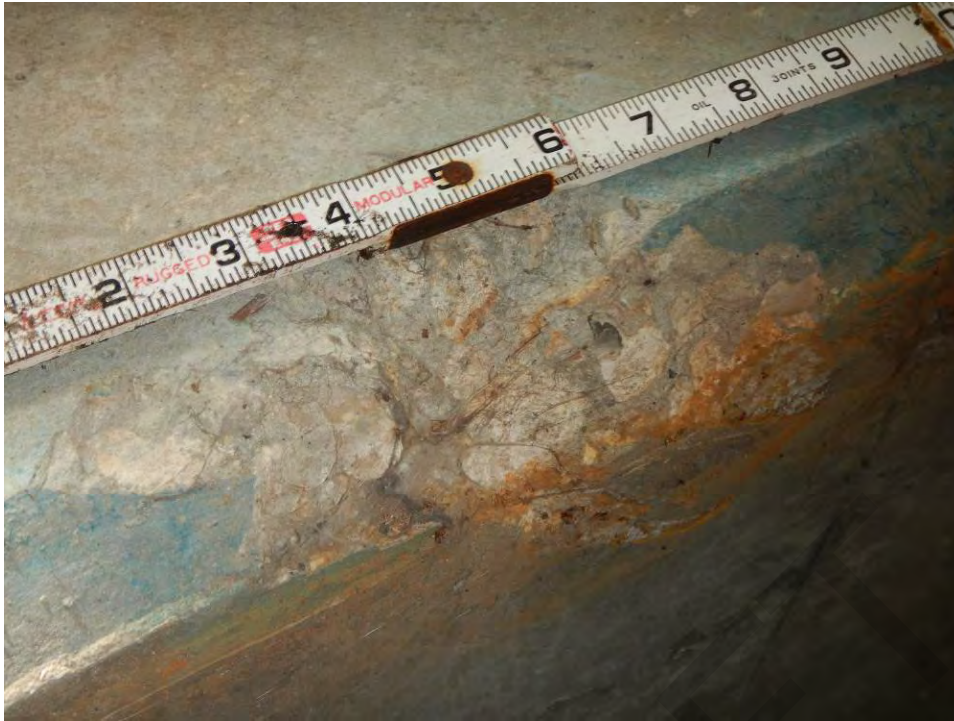
Figure 10-6: Concrete edge spall underside of arch

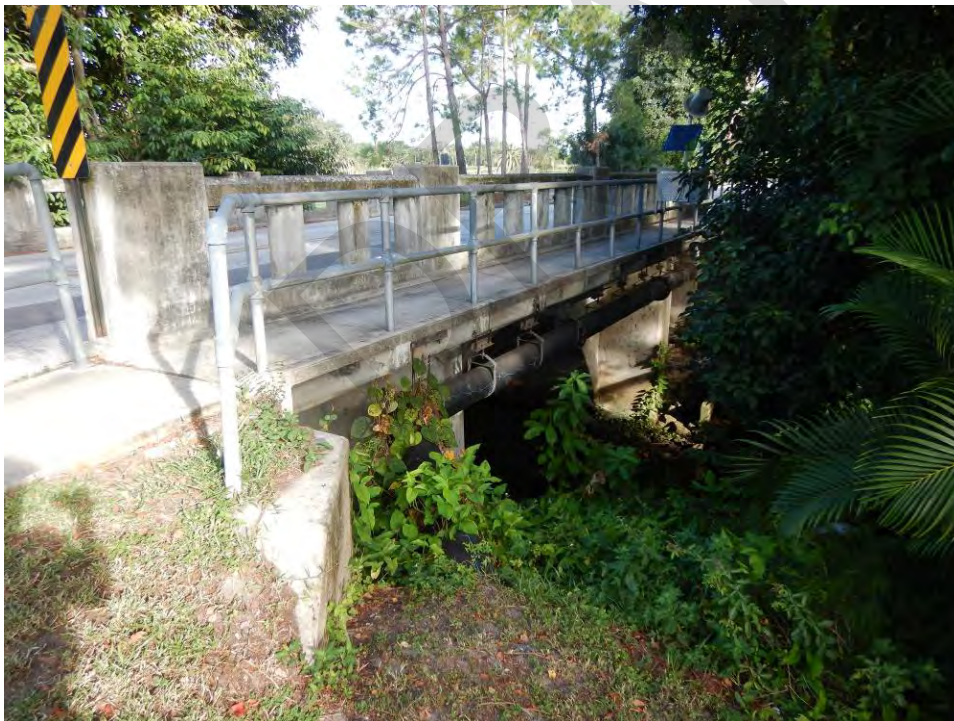
Figure 10-7: Bridge Section with obsolete crash barrier and sidewalk rail
