ARBORIST REPORT

HALLETT PARK FOR: THE TOWN OF BELLEAIR

Prepared by: Richard Peterika, FL-5893B & Dalton Smith, FL-9314A 12/22/2022

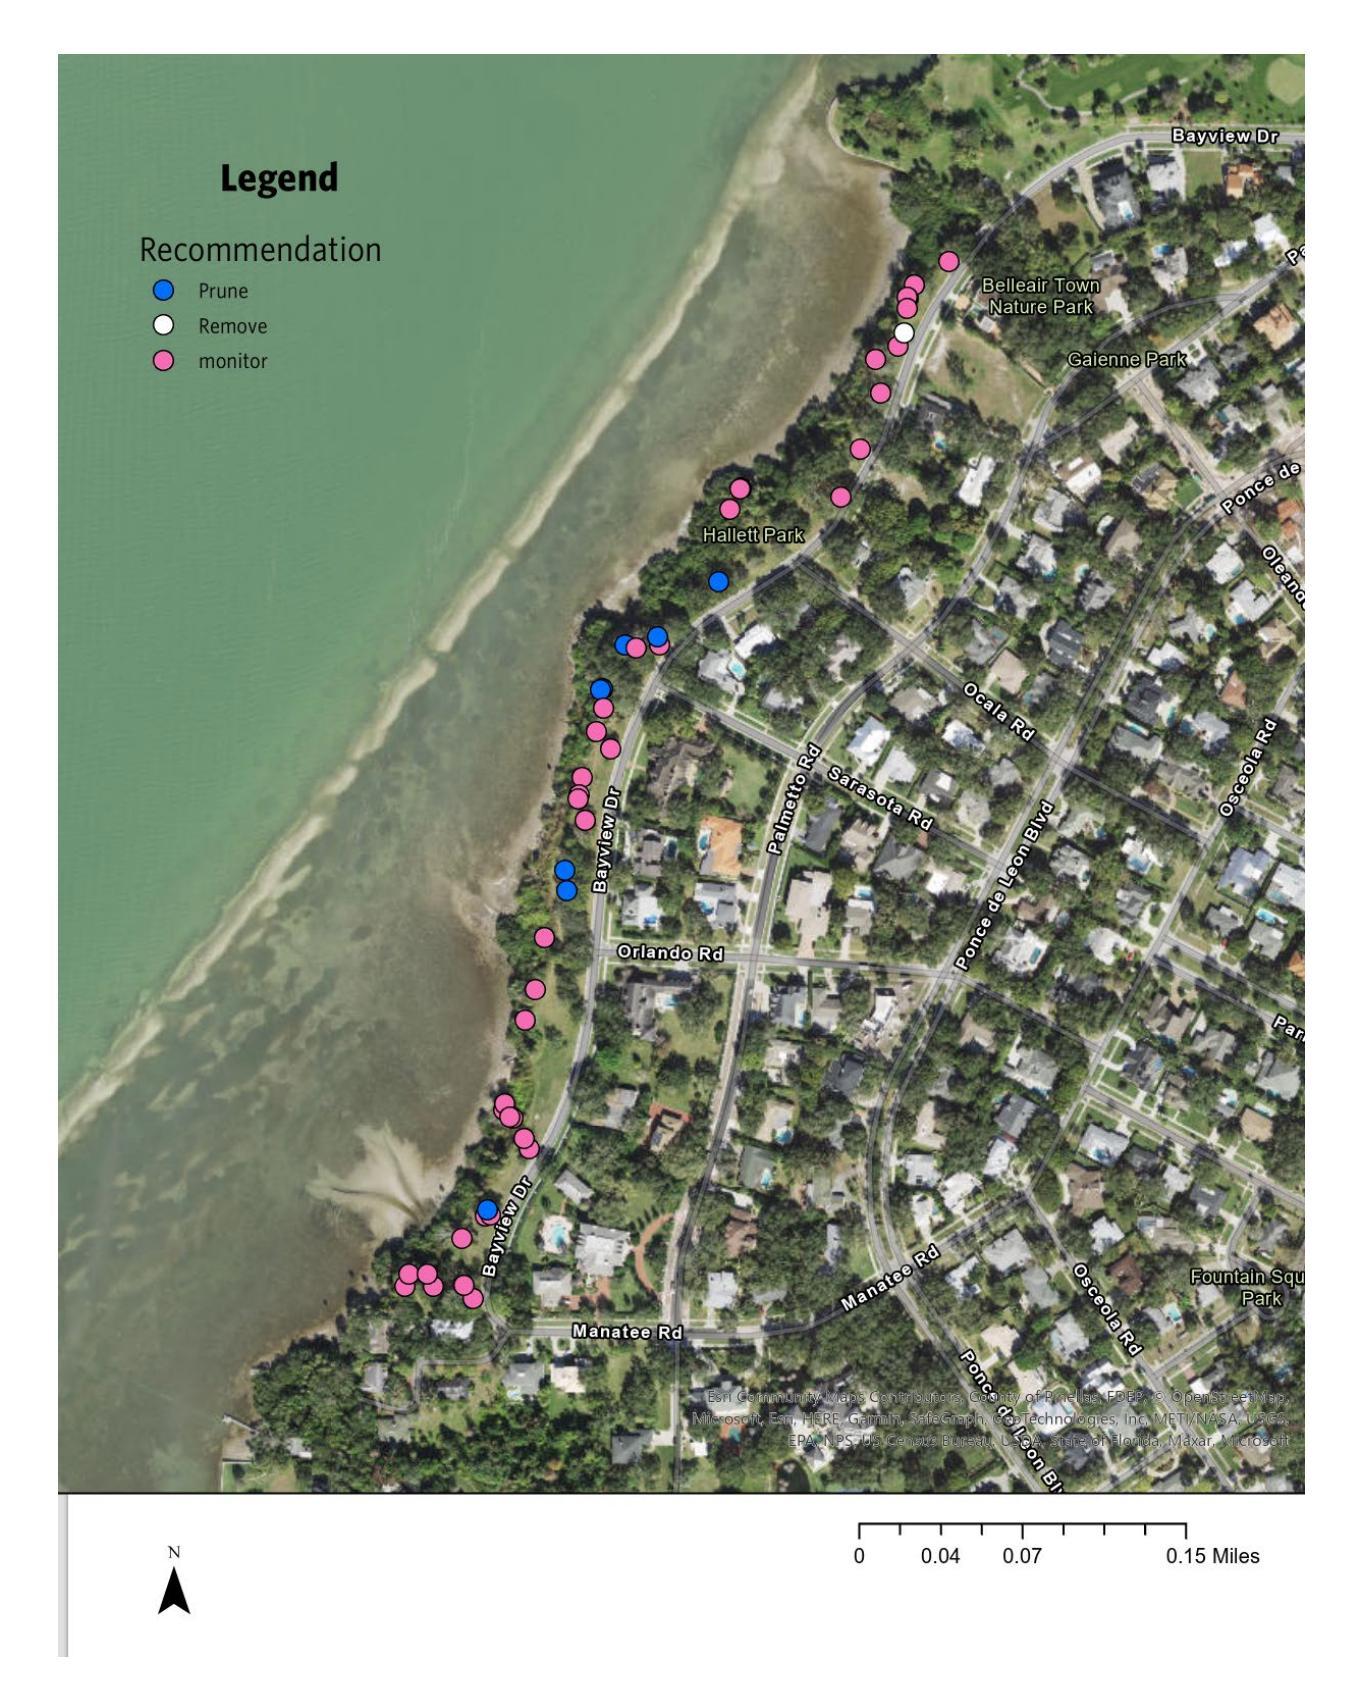
Figure 2 - Management Recommendations Map

One tree is recommended for removal in the inventory: Tree #98, tag #398. The condition of this tree was rated "poor," and the risk of whole tree failure cannot be lowered by any risk mitigation methods other than full removal.

Pruning is recommended for any trees adjacent to the benches within Hallett Park and with dead or dying branches that pose a risk to public safety.

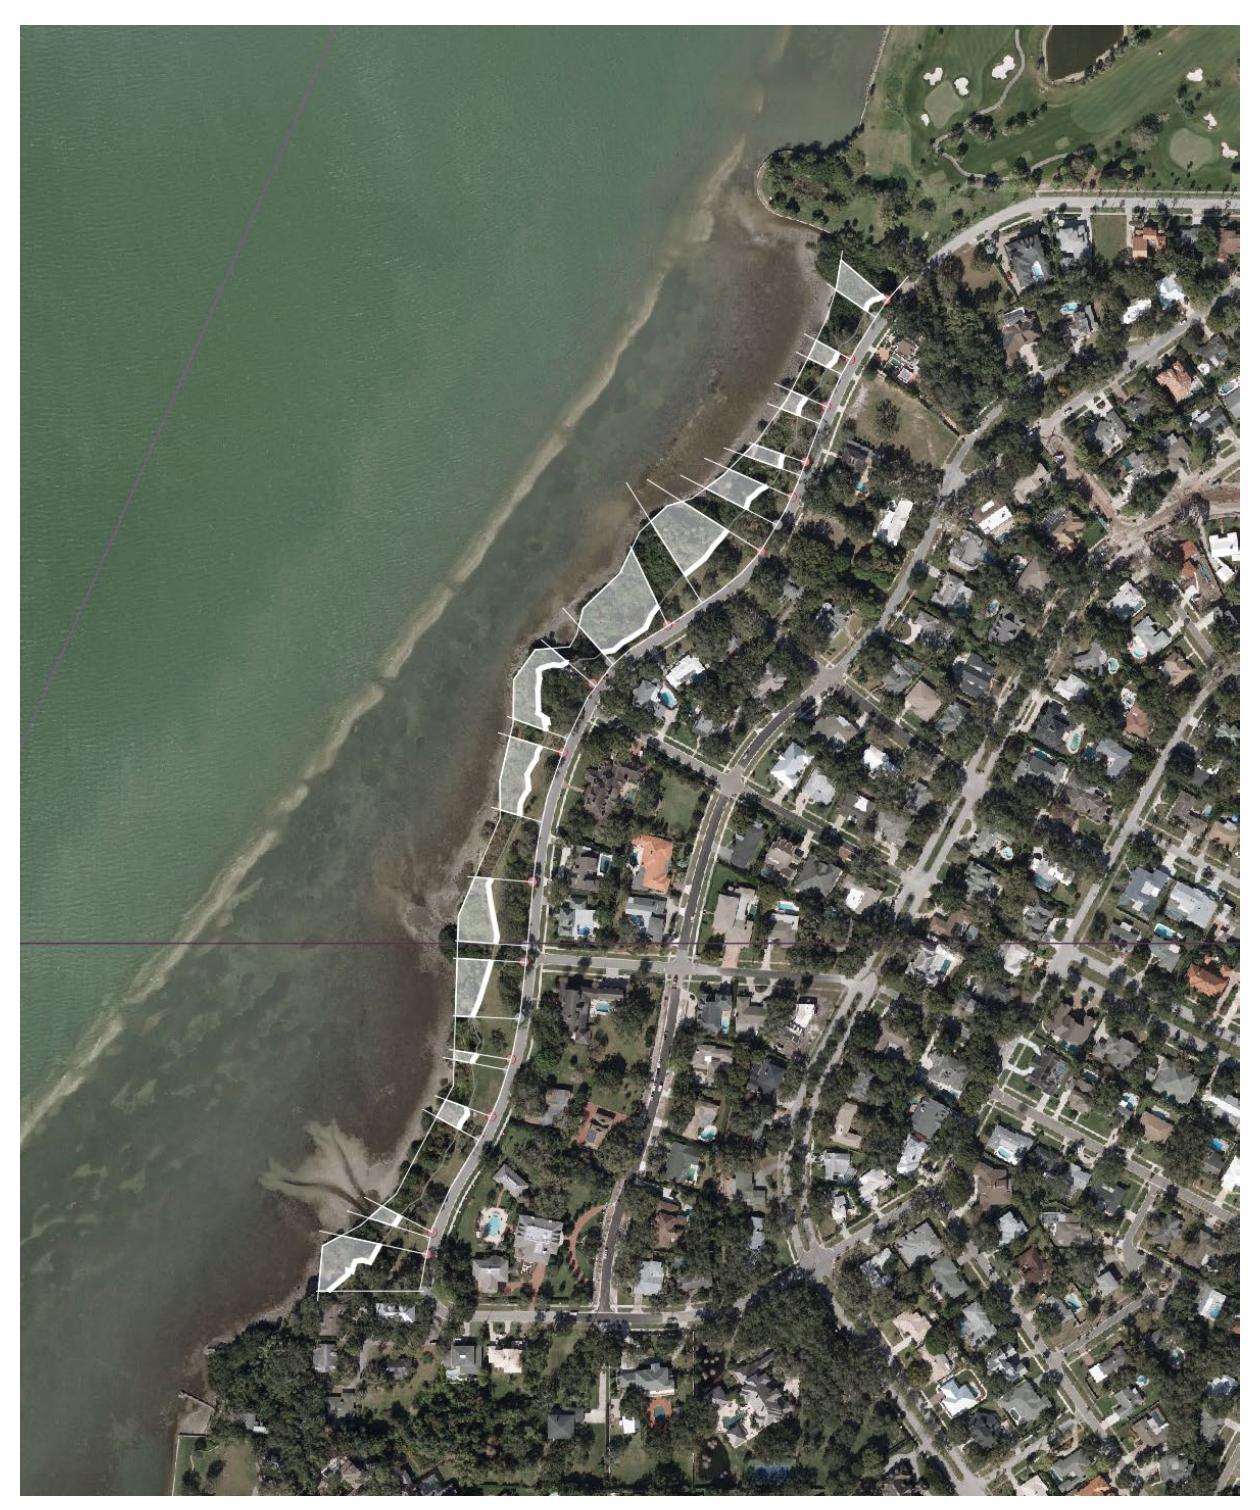
Figure 3 - Viewshed Area (Obstructions shown in White)

Oaks		Vir	nes	Inva	sives	Hic	kory	Pa	ms	Mang	roves
Area	Opacity	Found?	Prune?										
1	70	X										Х	Х
2	10							Х	X				
3	60			X	X			X		X			
4	90			Х	X				•	Х			
5	80	Х						Х		Х			
6	5 0	Х											
7	60	Х				Х	X					X	Х
8	80	Х		Х	X	X	Х						
9	90	Х		X	X	X	Х						
10	90	Х		X	X	X	Х			X			
11	80	Х				X	Х						
12	50	Х		X	X	Х	Х						
13	60	X											
14	70							Х		Х			
15	50	X										Х	Х

Hallett Park Tree Inventory By Dark Moss No pruning is recommended for the smaller diameter sand live oaks growing on the bluff slope obstructing the viewshed. Most view obstructions result from the canopy of these smaller trees, and topping would not be an appropriate pruning method for this species.

Sabal Palms growing on the bluff slope contribute to sight obstructions. Rather than prune the palm, we recommend that they be allowed to grow so that their crowns exist above the viewshed horizon line.

Brazillian Pepper (*Schinus terebinthifolia*) and Carrotwood (*Cupaniopsis anacardioides*) are the two most prominent invasive species that make up the sight obstructions. These two species may be pruned or cut back to a height not exceeding 50% of live foliage without adverse effects on the health of the trees. Removal is not recommended because the root systems may contribute to soil stabilization along the bluff.

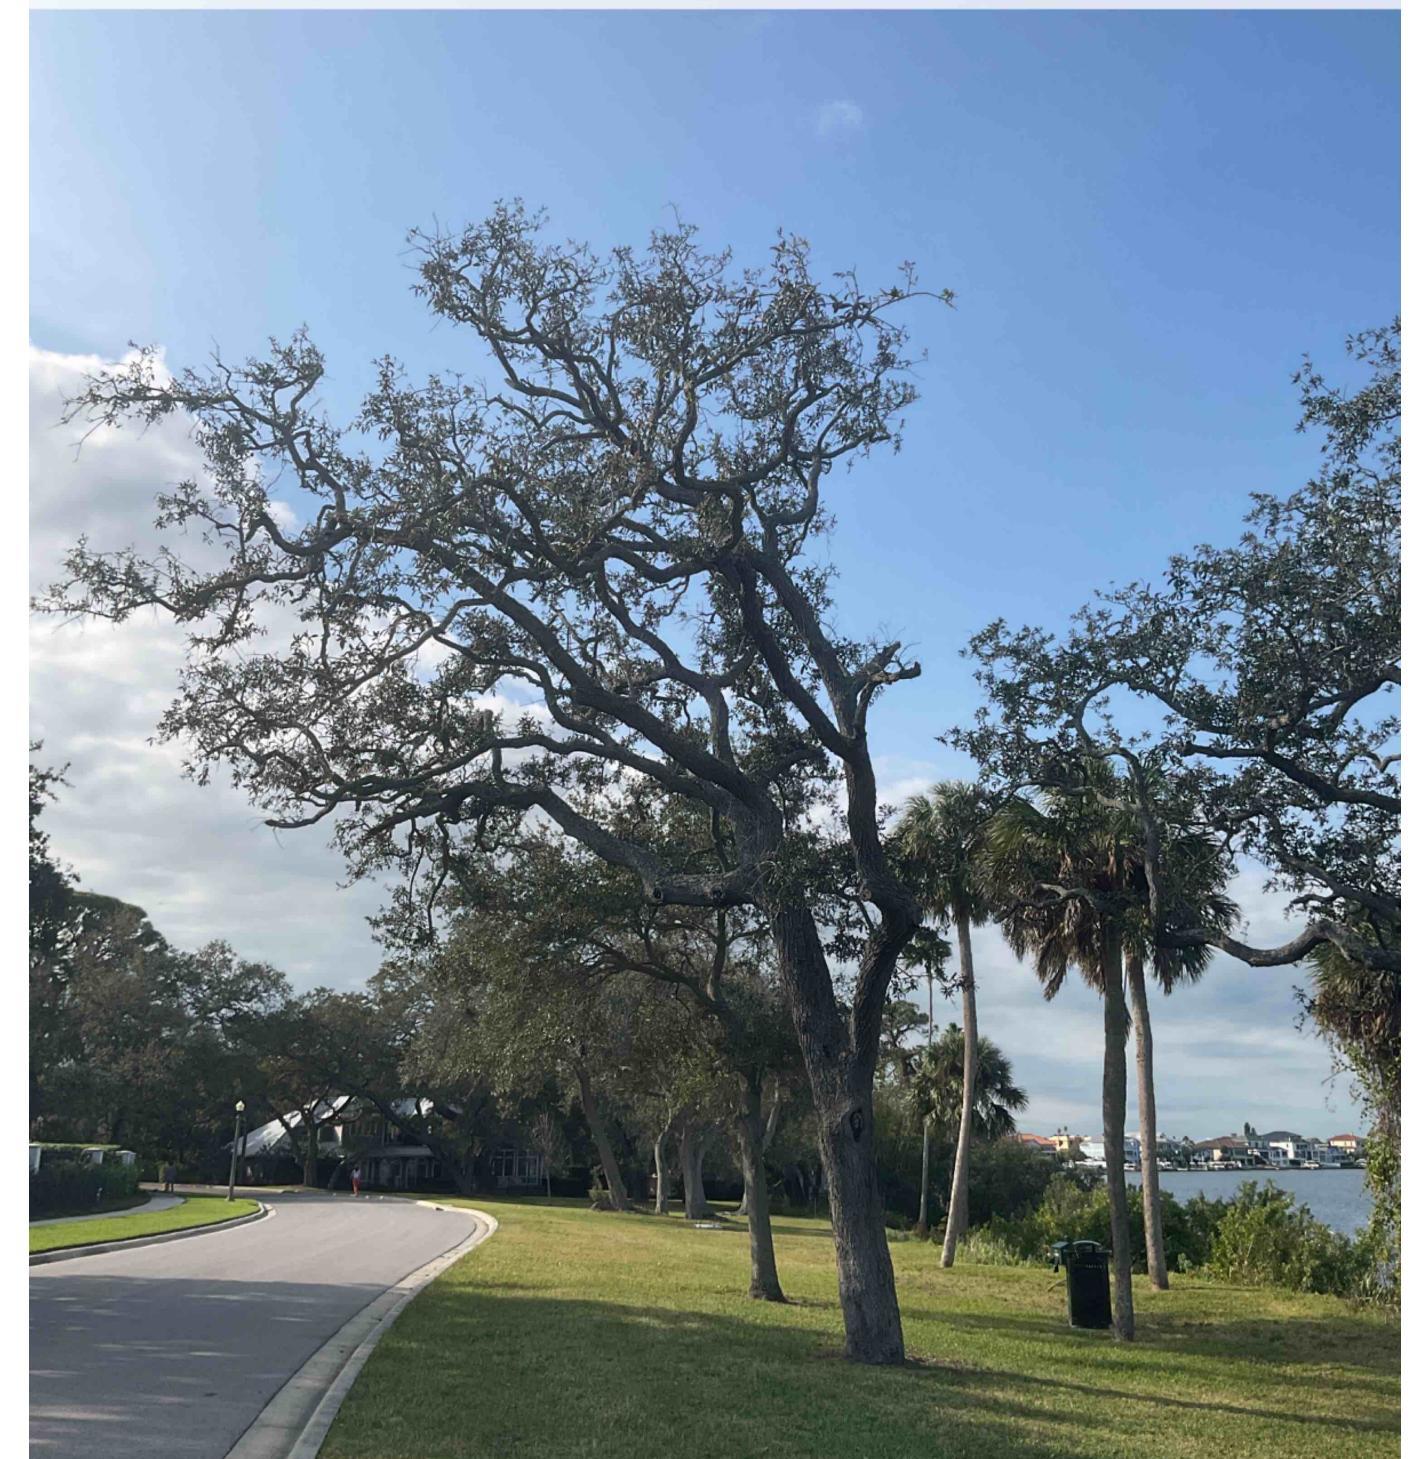
Tree Condition - Below Average Dark Moss Hallett Park 16 Dec 2022, 10:08:50
