BELLEAIR COUNTRY CLUB

SOUTHWEST FLORIDA WATER MANAGEMENT DISTRICT ERP APPLICATION - ENVIRONMENTAL NARRATIVE

JANUARY 2020

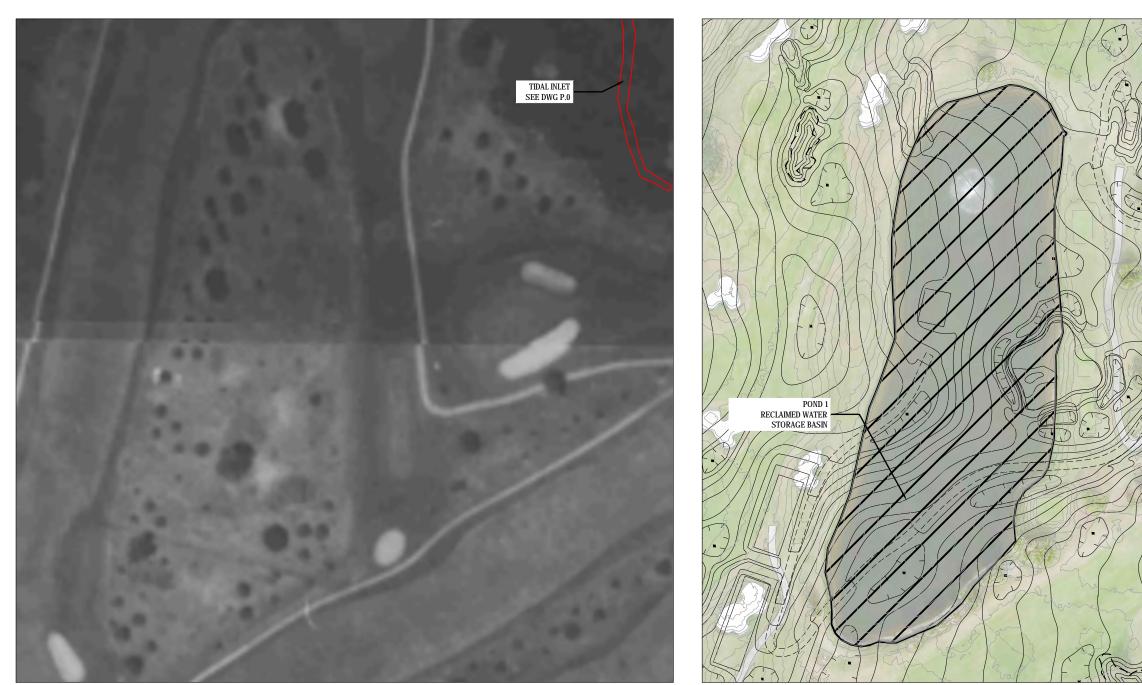
AERIAL - 1984 EXISTING AREA = 0.00 ACRES

AERIAL - 2018

EXISTING AREA: 2.17 ACRES FILL AREA: 2.17 ACRES REMAINING AREA: 0.00 ACRES

Surface Water ID	Size (Acres)
Pond 1	2.17
Pond 2	1.91
Pond 3	0.27
Pond 4	0.67
Total (Ponds)	5.02

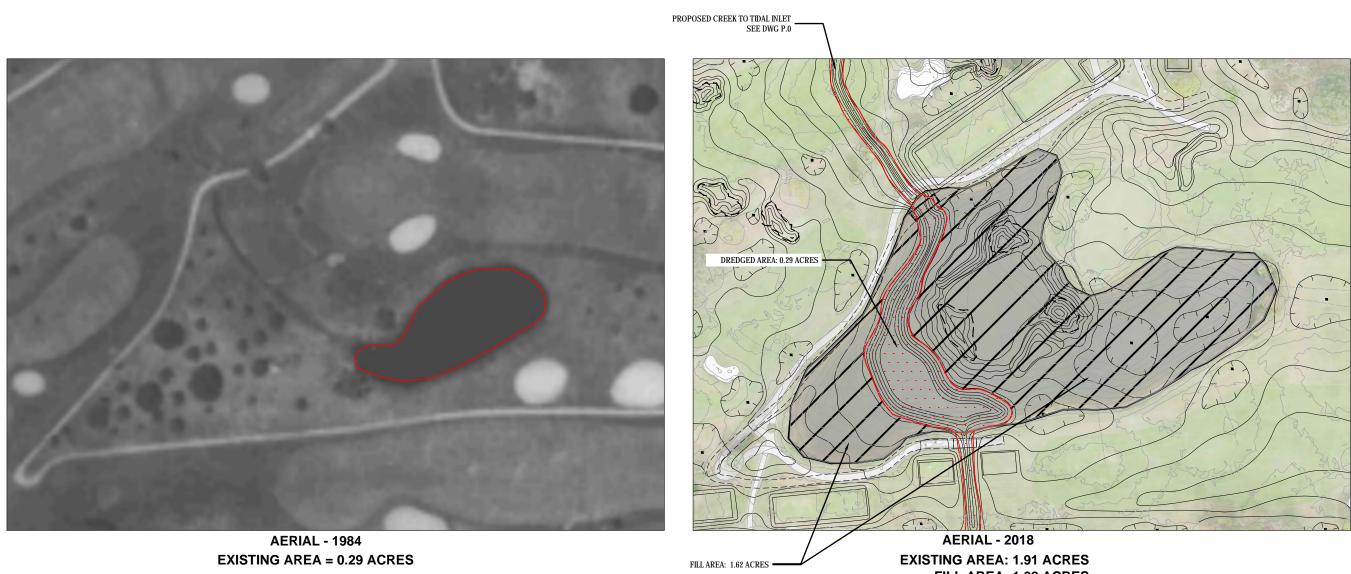
FILL AREA: 1.62 ACRES REMAINING AREA: 0.29 ACRES DREDGED AREA 0.29 ACRES

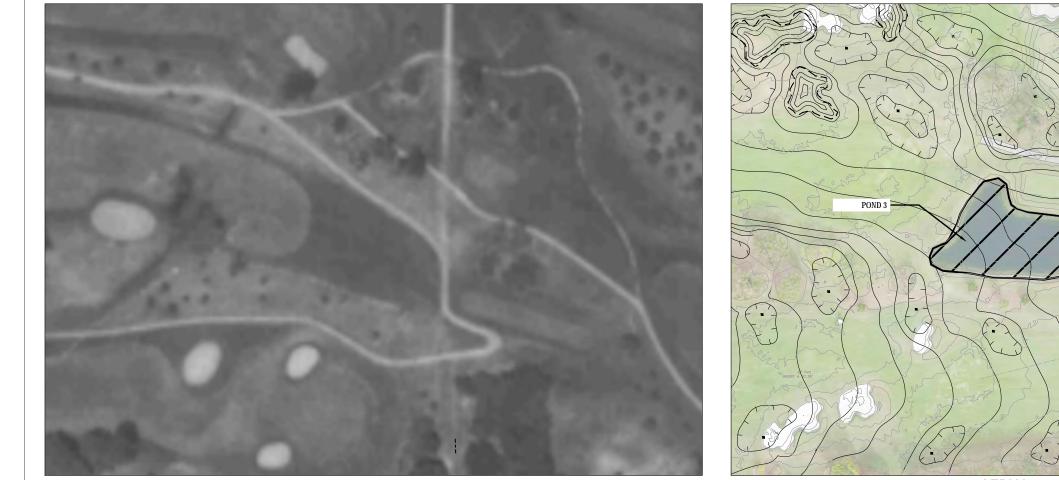
AERIAL - 1984 EXISTING AREA = 0.00 ACRES

AERIAL - 2018 EXISTING AREA: 0.27 ACRES FILL AREA: 0.27 ACRES **REMAINING AREA: 0.00 ACRES**

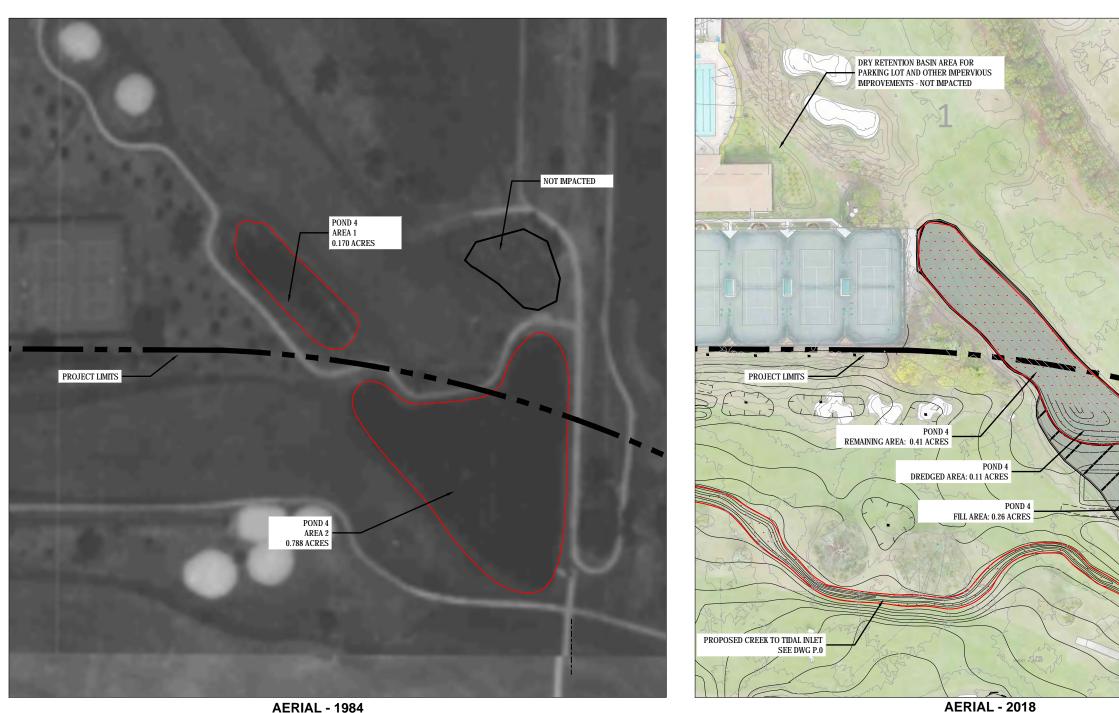
AERIAL - 1984 EXISTING AREA: 0.96 ACRES

EXISTING AREA: 0.67 ACRES FILL AREA: 0.26 ACRES REMAINING AREA: 0.41 ACRES

DREDGED AREA: 0.11 ACRES
