Investment Grade Audit

Investment Grade Audit For The Town of Belleair

Presented By: ABM Building Services, LLC.

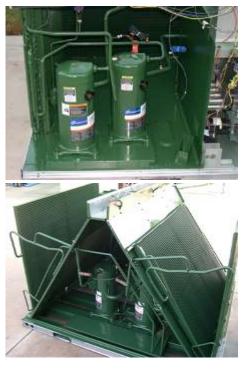
The east mechanical room is not air conditioned and the air handling unit is beginning to rust due to condensation onto the frame. The vent to the outside air is closed.

The slotted double doors on the East Mechanical room will be replaced. This mechanical room contains two (2) air conditioning air handlers and a larger electrical panel. We will condition this space to help with the rust and corrosion and to extend the life of the equipment in this space.

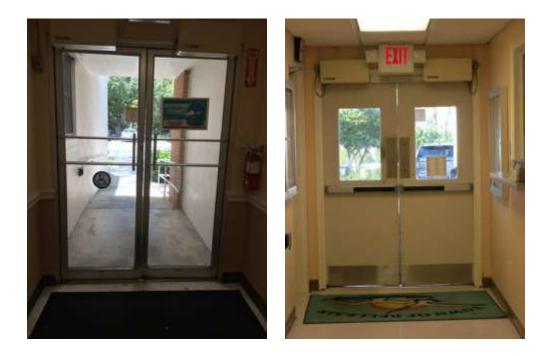
Infiltration of unconditioned air and exfiltration of condition air will lead to higher energy costs. Town Hall had not received a building envelope analysis or envelope modifications at any time in recent memory of staff. Air leakage is evident upon inspection. Several key areas of the building have been identified as energy inefficient.

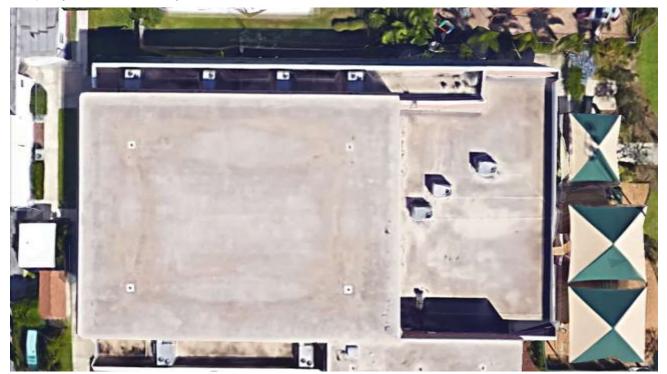
There are currently 6 Roof Top Units serving the Gym, RTUs 1-6 on the equipment list and as can be seen in the image above. The units are currently manually controlled, as described in the controls section. The space can be sufficiently cooled and dehumidified under most circumstances by RTU's 1 & 2, both ten (10) ton units. If additional capacity is needed for heavy load situations, RTU's 3 and 6 can handle the additional load.

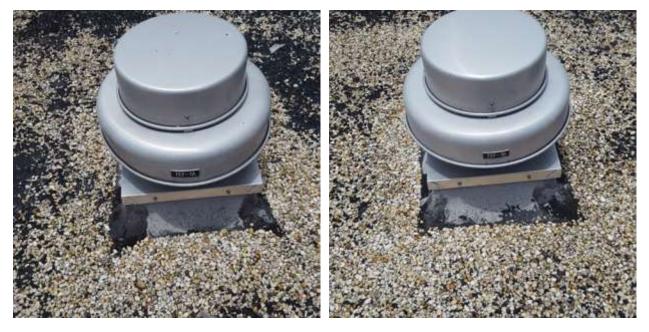
These are the two bathroom / locker room exhaust fans. They are in poor condition and will be replaced by higher efficiency exhaust fans.
