Town of Belleair

Meeting Agenda Infrastructure Board

[21-0018](#) Draft Bridge & Seawall Evaluation Report

Attachments: [2021-01-08 Belleair Bridge Seawall Inspection Report draft \(2\).pdf](#)

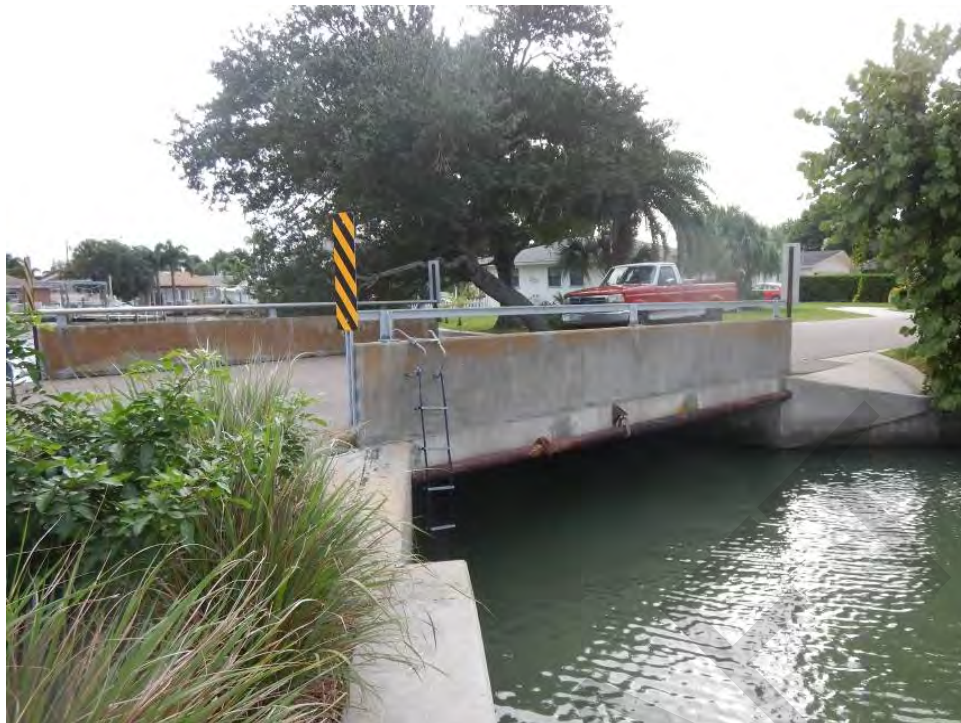
Figure 4-1: Bridge 155000 at Winston Drive

The bridge and wingwalls inspection found minor to moderate defects on the underside of the bridge deck and wingwalls. The overall condition ratings for the structure are:

The condition of the structure has not significantly changed since the 2019 FDOT inspection. The following field observations were noted during the inspection:

Most of the findings observed in the field and noted in the FDOT report are normal issues that will not compromise the structural integrity of the bridge and wingwalls. The observations and findings for this bridge are of low priority repairs. It is recommended to routinely perform basic maintenance such as concrete spall or crack repairs, cleaning areas of debris and joint repairs at this bridge location.

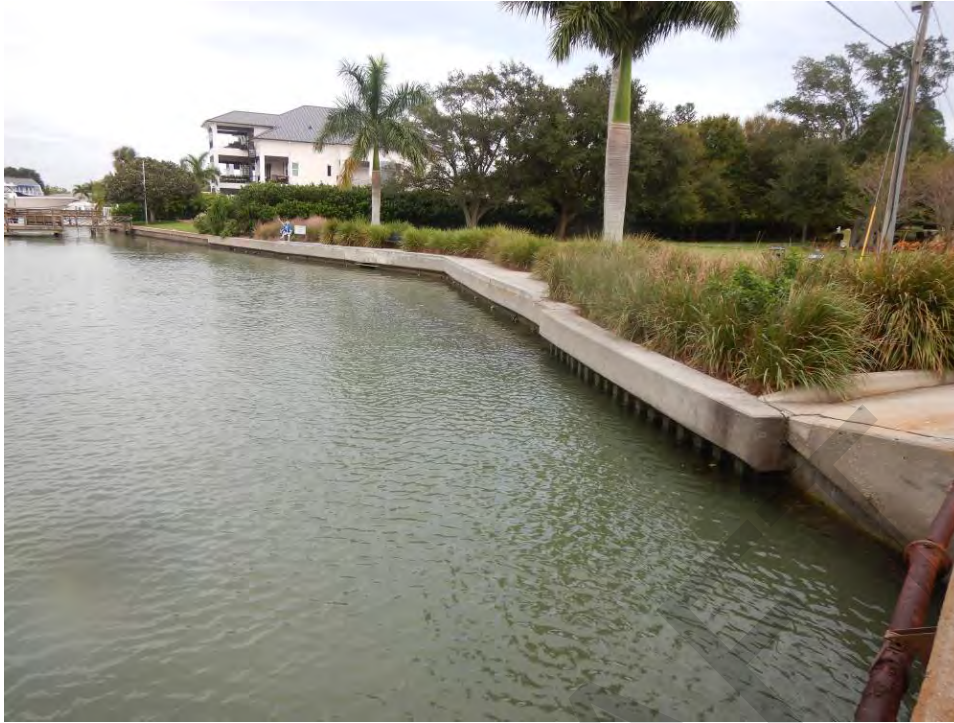
Figure 5-1: Overall view of the Winston Park Seawall

The seawall structure in Figure 5-1 is an extension of the northeast wingwall at Bridge 155000 that borders Clearwater Harbor and Winston Park. It functions as a retaining system for the embankment that is Winston Park. This retaining system consists of cantilever steel sheet piles and anchored 4-foot wide concrete panels. The seawall measured approximately 162 feet long with a height from top of coping to mudline of five (5) feet. The wall has a 2-foot by 2-foot concrete cap at the top of the wall panels and a 5-foot wide concrete sidewalk immediately landward from the cap. Based on the condition observed, the concrete cap and steel sheet pile wall section were installed recently.

- The 25-foot section of steel sheet pile wall had no visible defects. The section seemed to have been repaired where the sheet piles were driven in front of damaged concrete panels.
- Voids seen from the water side of the concrete panels were mainly between the joints of the panels and measured up to two (2) feet deep. Spalls were observed as large as four (4) inches wide for the full joint height of the panel, as seen in Figure 5-2.
- Several horizontal and vertical hairline cracks are present. Some span the entire width of the seawall panels, as seen in Figure 5-3.

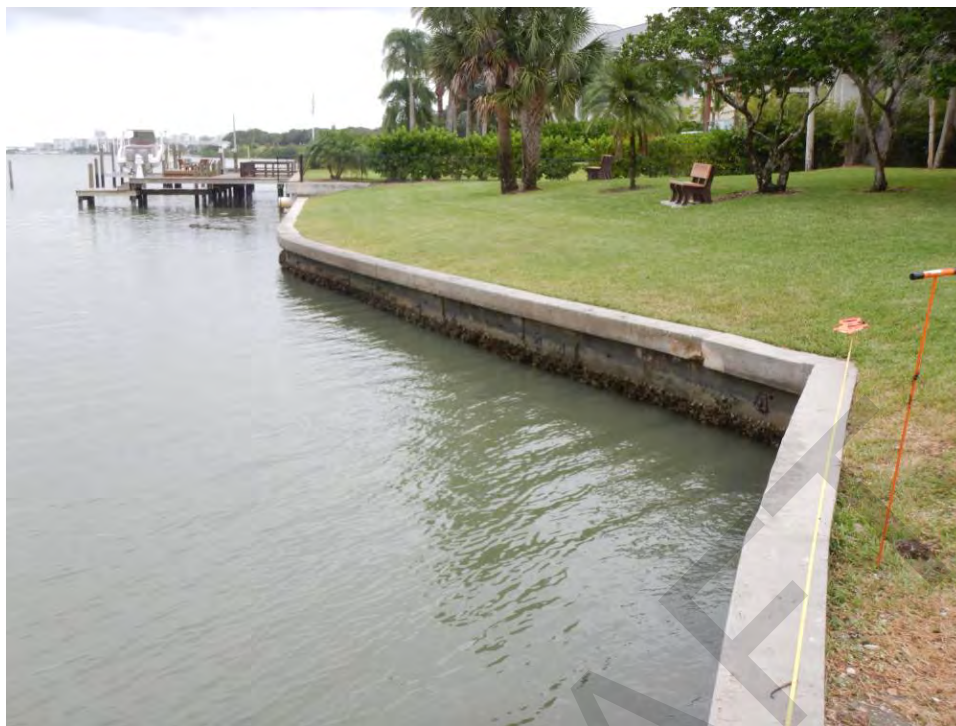
Figure 7-1: Overall view of the Thompson Park Seawall

The seawall structure shown in Figure 7-1 is an extension of Bridge 155001 northeast wingwall that borders Clearwater Harbor and Thompson Park. It functions as a retaining system for the embankment that is Thompson Park. This retaining system consists of anchored four (4) foot wide concrete panels. The anchors are 2-inch diameter steel rods with a 6-inch by 6-inch steel washer plate. Behind the concrete panels is a mechanically stabilized earth (MSE) system constructed of geotextile material. The seawall measured approximately 162 feet long with a height of four (4) feet to the mudline. The wall has a 2-foot by 2-foot concrete cap at the top of the wall panels.

- Hairline cracks throughout the entire cap with additional spalling in some areas of the underside with exposed steel reinforcement, as seen in Figure 7-10.

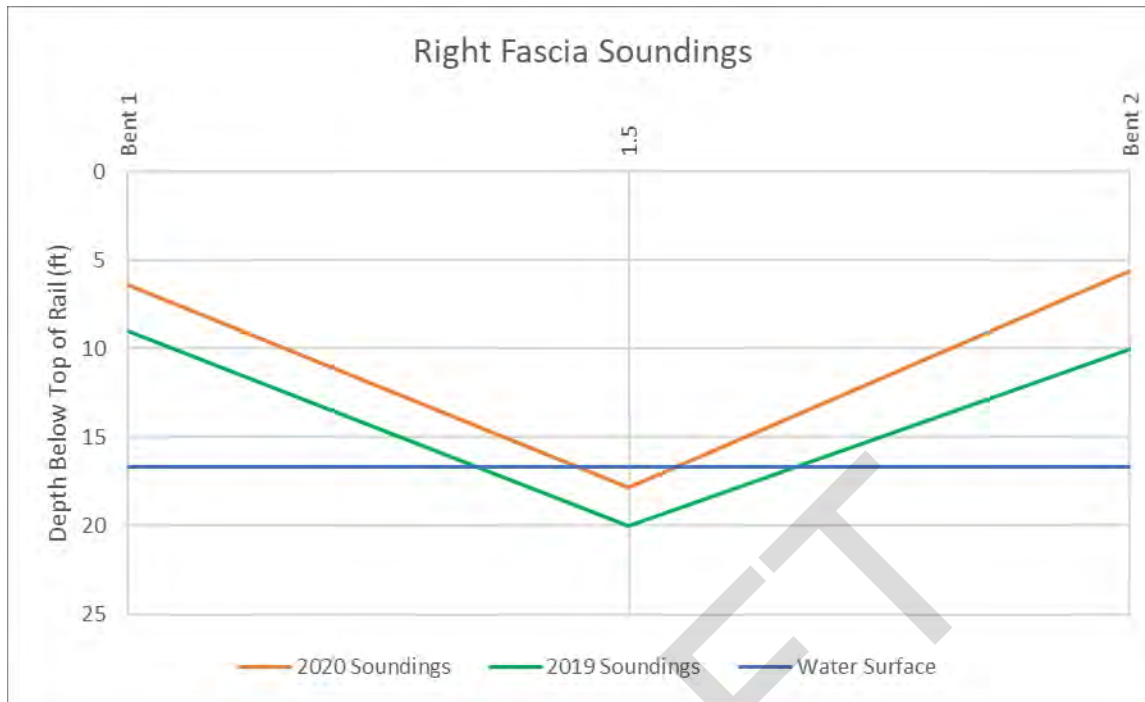
Graph 8-1 Bridge 155003 Right Fascia Cross Section

STATION	Fascia Left 2020	Fascia Left 2019	Fascia Left Change	Fascia Right 2020	Fascia Right 2019	Fascia Right Change
Bent 1	6.5	8.0	+1.5	6.4	9.0	+2.6
1.5	16.8	18.0	+1.2	17.8	20.0	+2.2
Bent 2	6.0	9.0	+3.0	5.6	10.0	+4.4

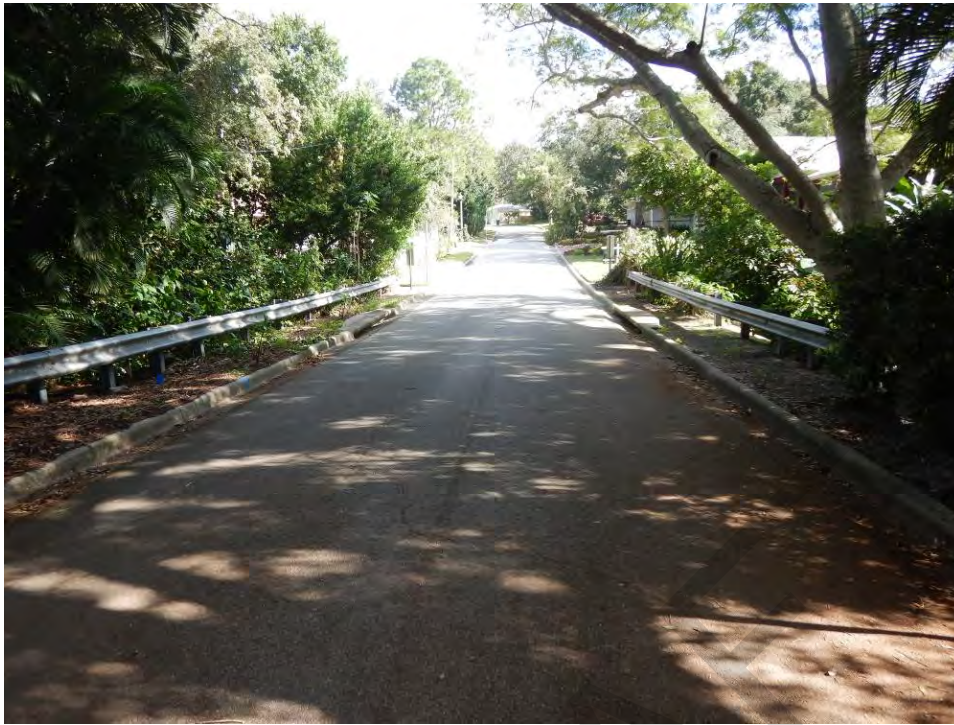
Figure 9-1: Bridge 155004 at Bayview Drive

The structure should be monitored every 24 months per BIRM for addition irregularities that could further deteriorate of the structural elements. Bridge 155004 was built in 1994 and is currently 26 years old. Based on the age, typical design life of bridges, its exposure to salt water, and its current condition, it is not expected for this bridge to require major maintenance repairs in the next 20 years.

The findings observed in the field and noted in the 2019 FDOT inspection report are normal issues that will not compromise the structural integrity of the precast culvert and wingwalls. The observations and findings for this bridge are of low priority repairs. It is recommended to routinely perform basic maintenance such as concrete spall or crack repairs, cleaning areas of debris and joint repairs to name a few.

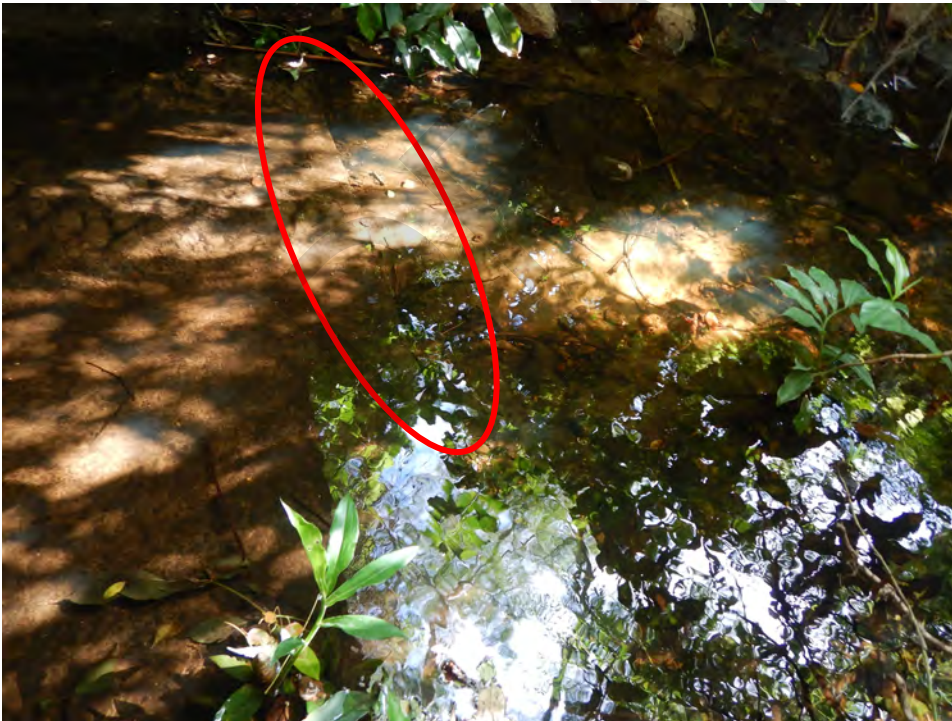
Figure 9-9: Example of exposed toe on the upstream side of the structure
