Re: **Bridge and Seawall Evaluations**

BRIDGE AND SEAWALL EVALUATIONS

Town of Belleair, FL

January 5, 2021

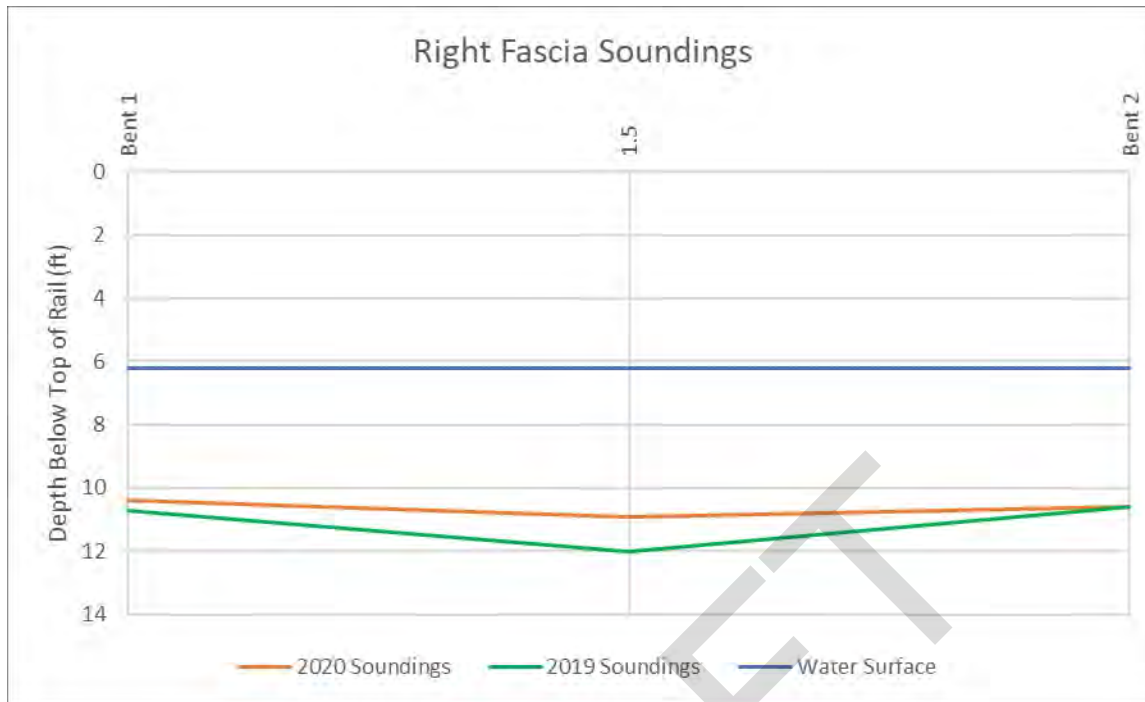
Graph 4-1 Bridge 155000 Right Fascia Cross Section

STATION	Fascia Left 2020	Fascia Left 2019	Fascia Left Change	Fascia Right 2020	Fascia Right 2019	Fascia Right Change
Bent 1	10.3	11.5	+1.2	10.4	10.7	+0.3
1.5	10.8	11.8	+1.0	10.9	12.0	+1.1
Bent 2	10.3	10.4	+0.1	10.6	10.6	0.0

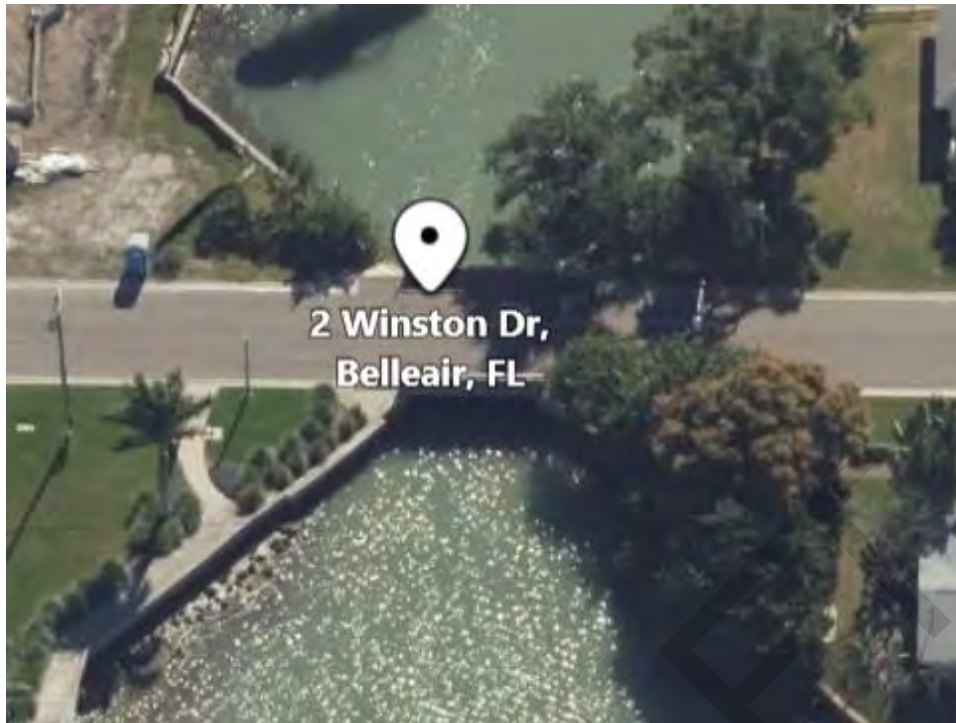
Figure 4-2: Aerial view of Bridge 155000 at Winston Drive

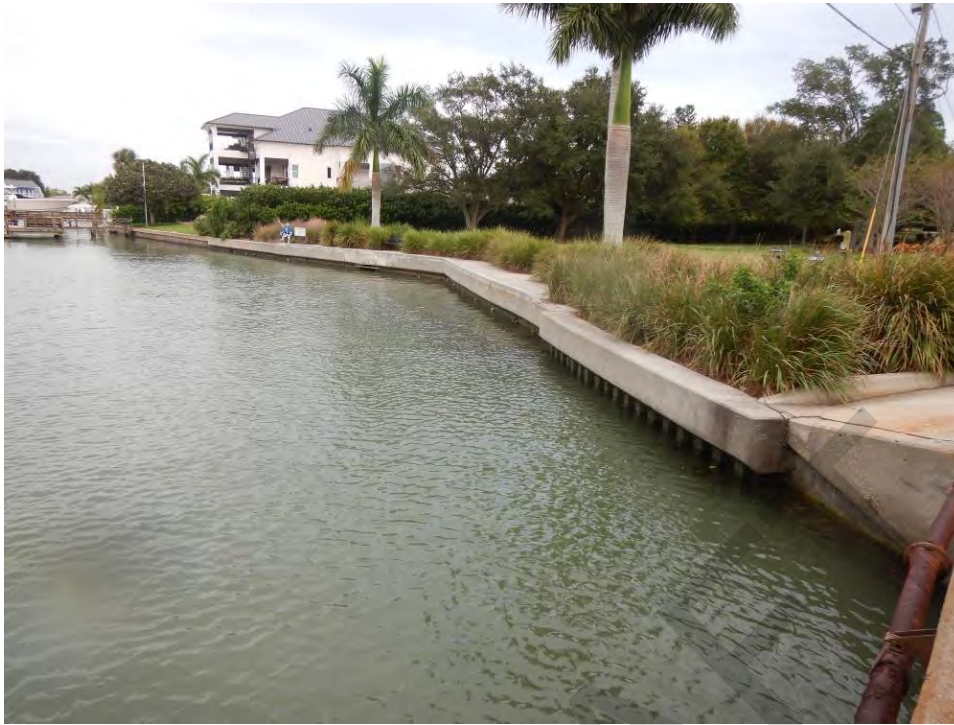
Figure 5-1: Overall view of the Winston Park Seawall

The seawall structure in Figure 5-1 is an extension of the northeast wingwall at Bridge 155000 that borders Clearwater Harbor and Winston Park. It functions as a retaining system for the embankment that is Winston Park. This retaining system consists of cantilever steel sheet piles and anchored 4-foot wide concrete panels. The seawall measured approximately 162 feet long with a height from top of coping to mudline of five (5) feet. The wall has a 2-foot by 2-foot concrete cap at the top of the wall panels and a 5-foot wide concrete sidewalk immediately landward from the cap. Based on the condition observed, the concrete cap and steel sheet pile wall section were installed recently.

- The 25-foot section of steel sheet pile wall had no visible defects. The section seemed to have been repaired where the sheet piles were driven in front of damaged concrete panels.
- Voids seen from the water side of the concrete panels were mainly between the joints of the panels and measured up to two (2) feet deep. Spalls were observed as large as four (4) inches wide for the full joint height of the panel, as seen in Figure 5-2.
- Several horizontal and vertical hairline cracks are present. Some span the entire width of the seawall panels, as seen in Figure 5-3.

The Winston Park Seawall is in "Satisfactory" condition and it is recommended that a French drain be installed behind the seawall where loss of fill has occurred. The estimated cost is \$5,000.

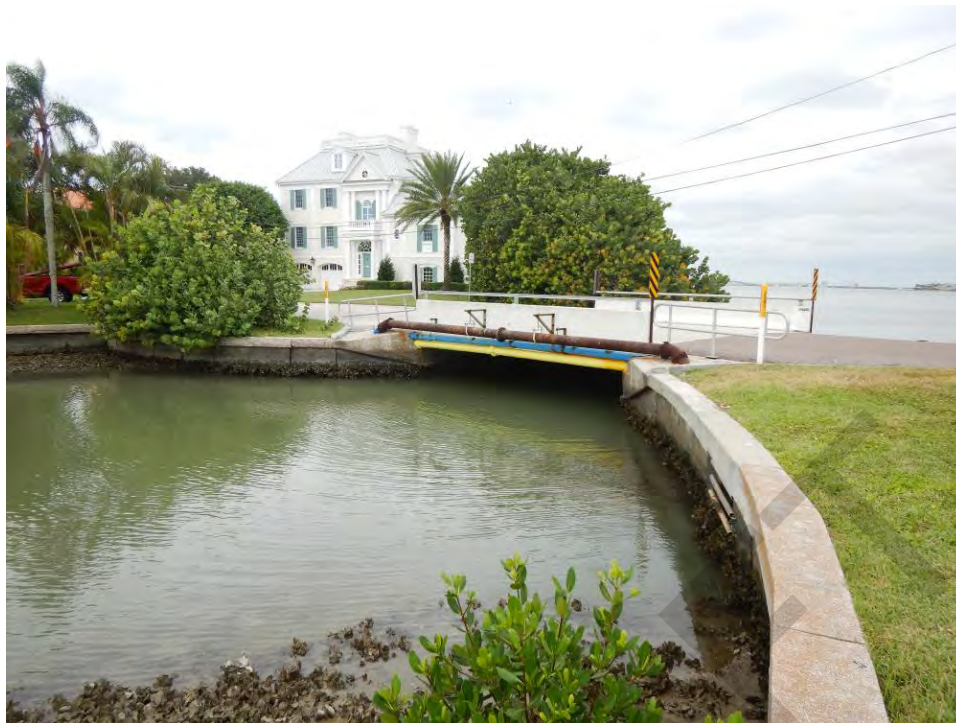
Figure 6-1: Bridge 155001 at North Pine Circle

Bridge 155001 at North Pine Circle, shown in Figures 6-1 and 6-2, was built in 1950 and spans a non-navigable waterway on the east shore of Clearwater Harbor. The bridge is a simply supported, single span structure measuring 28.25 feet wide with a length of 25 feet. The superstructure consists of six (6) 48-inch wide precast prestressed concrete slab beams with concrete deck and asphalt overlay. The bridge has 32-inch side barriers with single bullet rails along the full length of the bridge main span. The shoreline adjacent to the bridge has 11-foot long wingwalls at each corner of the abutments. A utility penetrates the southeast wingwall adjacent to the abutment as seen in Figure 6-4. This bridge is identical to the Bridge 155000 at Winston Drive.

A NBIS routine inspection was conducted in 2019 that identified areas of concern which included but were not limited to concrete spalls, cracks, and delamination in various sections of the superstructure and substructure elements. Exposed steel reinforcing bars are present and rust spots with some corrosion were also listed. The structure was listed as scour critical. Minor maintenance repairs were completed since the 2019 FDOT inspection, including spall repairs at the abutments (Figure 6-5) and bridge reflectors were added to the concrete barriers at the beginning and end of the concrete barriers. An example of these repairs can be seen in Figure 6-3.

The findings observed in the field and noted in the 2019 FDOT inspection report are normal issues that will not compromise the structural integrity of the bridge and wingwalls. The observations and findings for this bridge are of low priority repairs. It is recommended to routinely perform basic maintenance such as concrete spall or crack repairs, cleaning areas of debris and joint repairs.

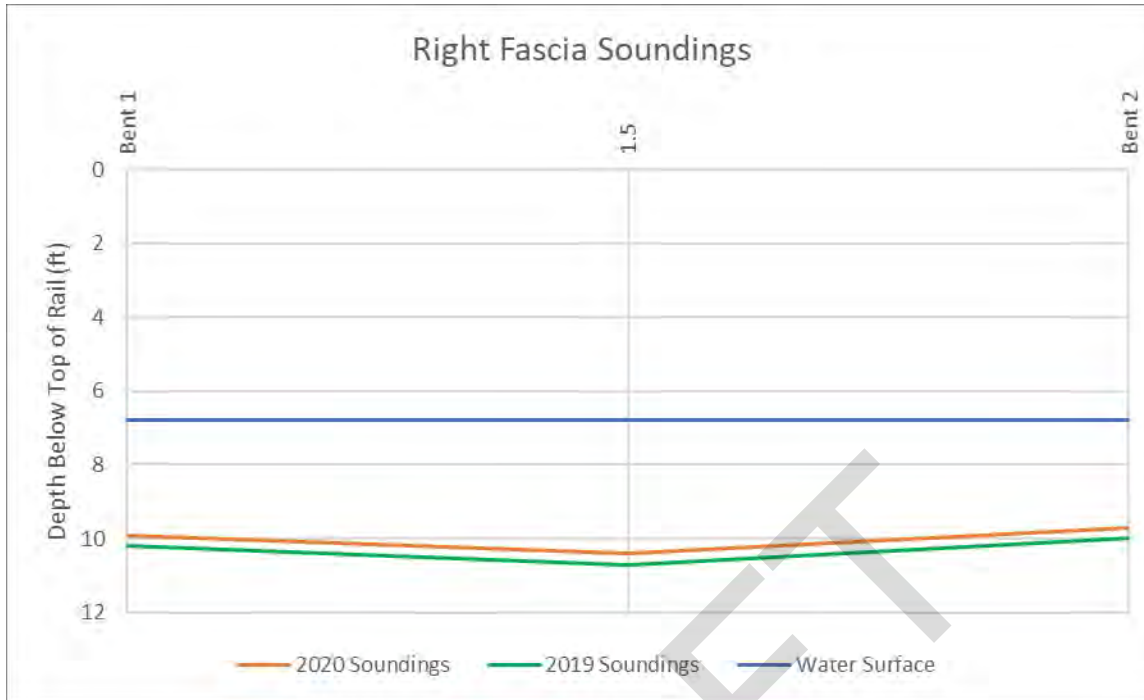
Graph 6-1 Bridge 155001 Right Fascia Cross Section

STATION	Fascia Left 2020	Fascia Left 2019	Fascia Left Change	Fascia Right 2020	Fascia Right 2019	Fascia Right Change
Bent 1	10.3	10.7	+0.4	9.9	10.2	+0.3
1.5	10.6	11.0	+0.4	10.4	10.7	+0.3
Bent 2	10.2	10.6	+0.4	9.7	10.0	+0.3

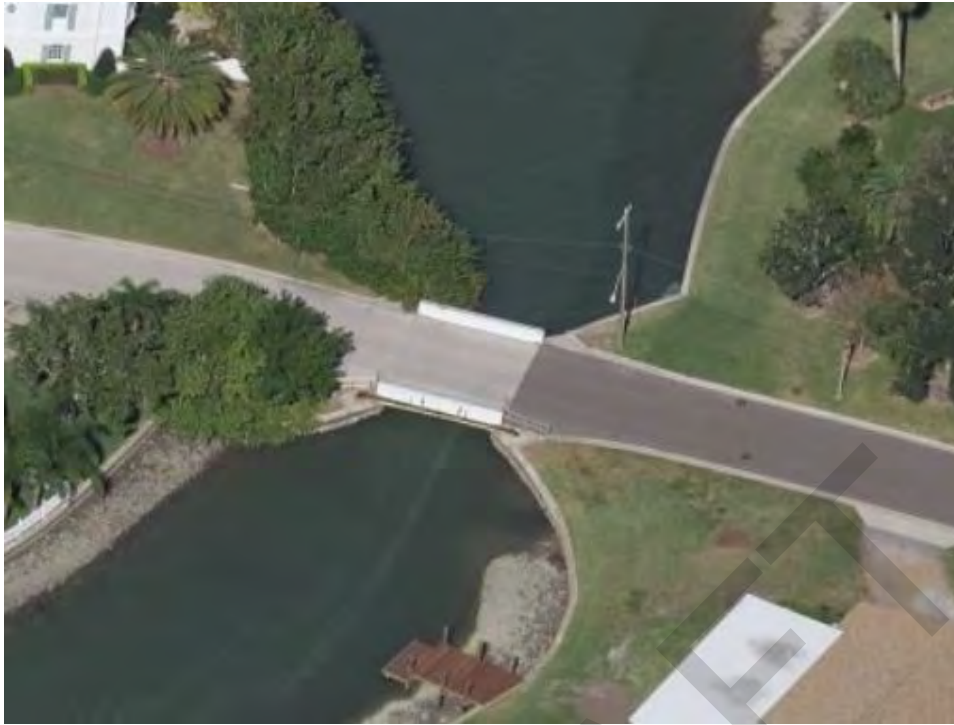
Figure 6-2: Aerial view of Bridge 155001 at North Pine Circle

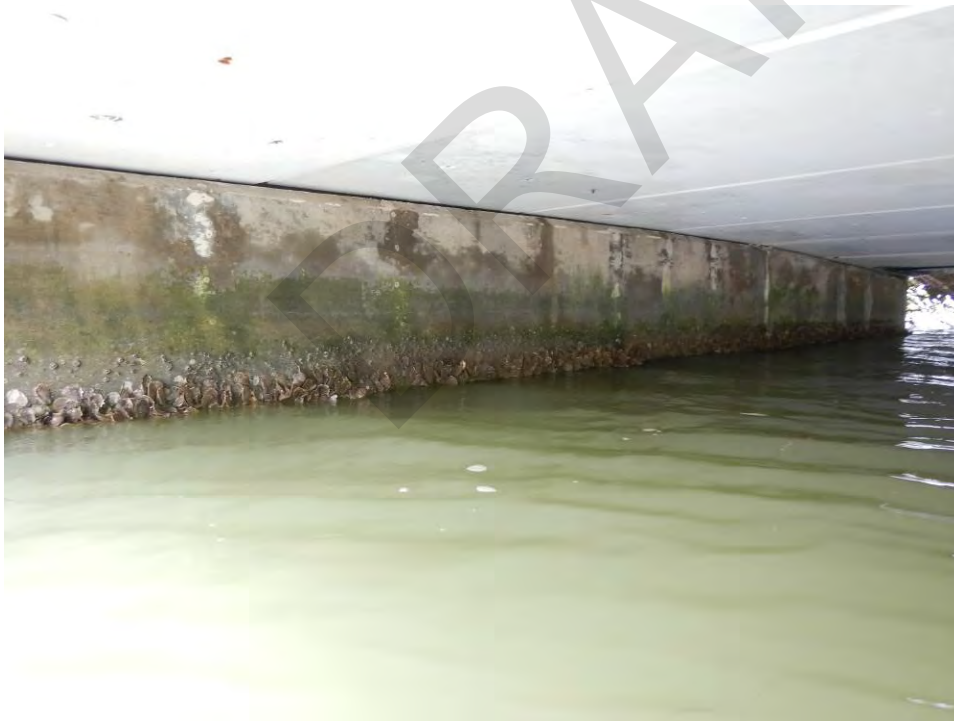
Figure 6-5: Typical view of Abutment

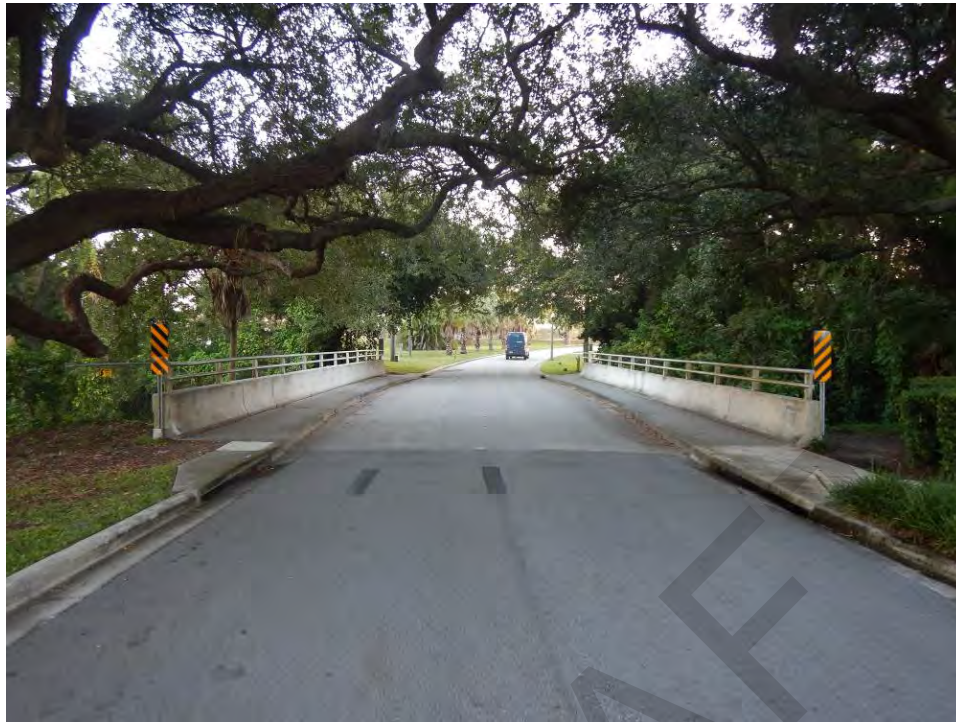
Figure 8-1: Bridge 155003 at Bayview Drive

Bridge 155003 at Bayview Drive, shown in Figures 8-1 and 8-2, was built in 1992 and spans Exotic Creek, a non-navigable waterway that flows into Clearwater Harbor. The bridge is a simply supported, single span structure measuring 37 feet wide with a length of 50 feet. Approach slabs are 20 feet long at each abutment. The superstructure consists of five (5) prestressed precast concrete double tee beams with concrete deck overlay. The bridge has 6-foot wide sidewalks and 32-inch barriers with double bullet rails along the length of the bridge main span and approach slabs on each side. Wingwalls at each corner of the abutments protect the embankment slope.

The findings observed in the field and noted in the 2019 FDOT inspection report are normal issues that will not compromise the structural integrity of the bridge and wingwalls. The observations and findings for this bridge are of low priority repairs. It is recommended to routinely perform basic maintenance such as concrete spall or crack repairs, cleaning areas of debris and joint repairs to name a few.

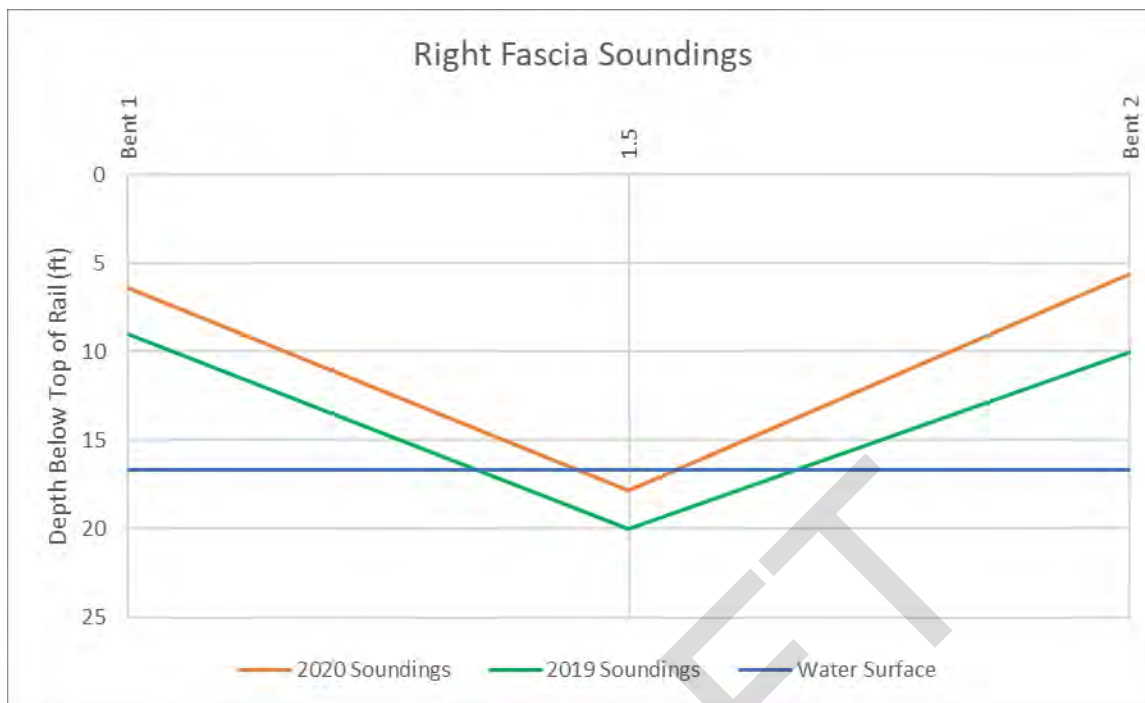
Graph 8-1 Bridge 155003 Right Fascia Cross Section

STATION	Fascia Left 2020	Fascia Left 2019	Fascia Left Change	Fascia Right 2020	Fascia Right 2019	Fascia Right Change
Bent 1	6.5	8.0	+1.5	6.4	9.0	+2.6
1.5	16.8	18.0	+1.2	17.8	20.0	+2.2
Bent 2	6.0	9.0	+3.0	5.6	10.0	+4.4

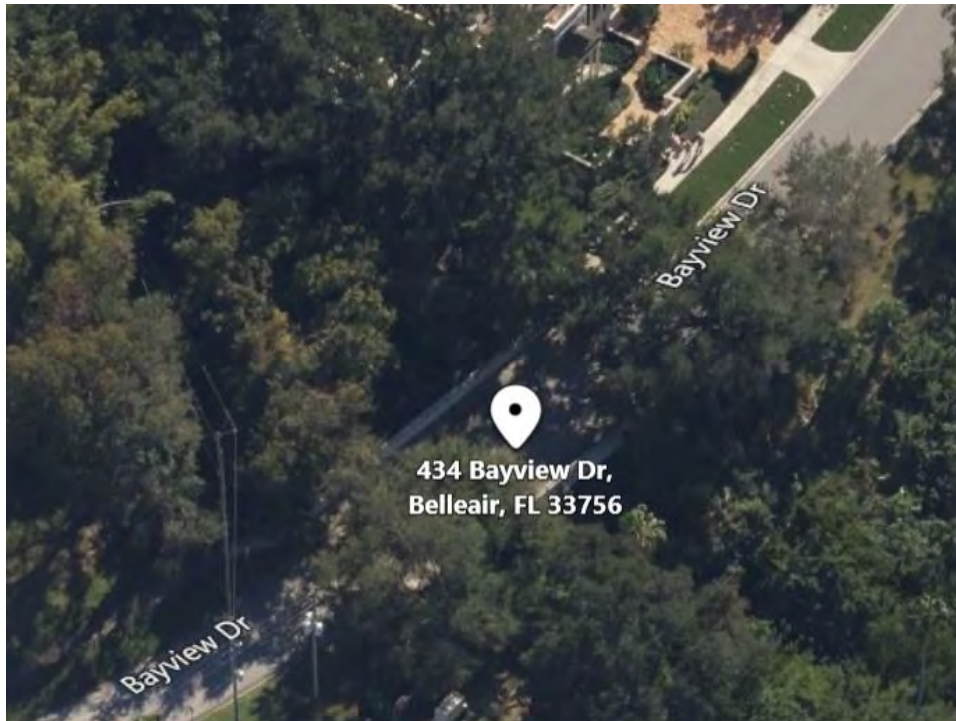
Figure 8-2: Aerial view of Bridge 155003 at Bayview Drive

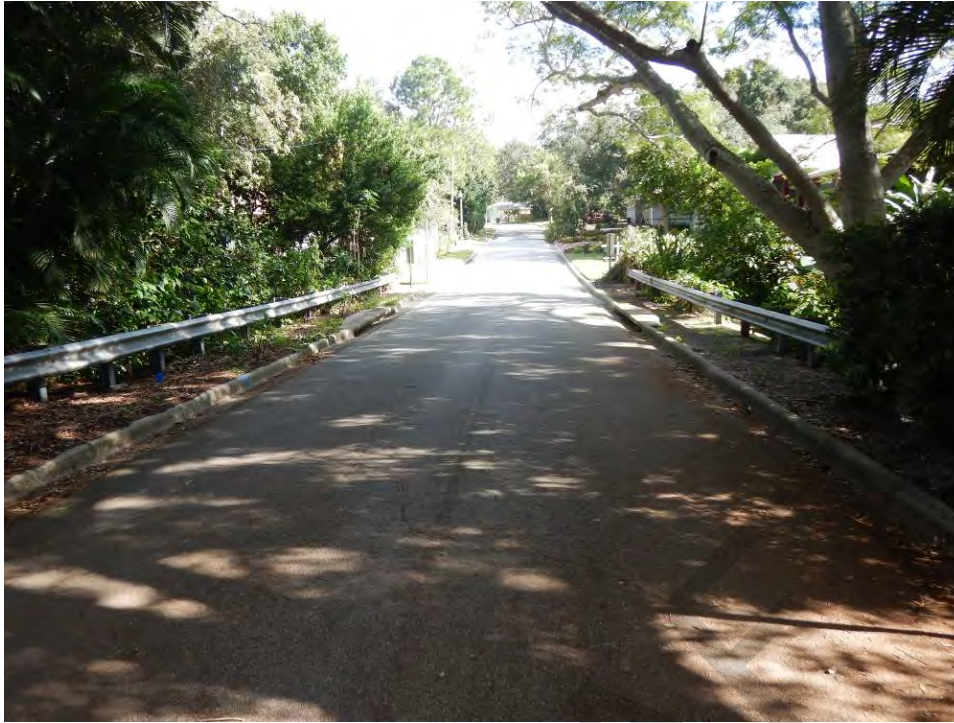
Figure 9-1: Bridge 155004 at Bayview Drive

Bridge 155004 at Overbrook Drive, shown in Figures 9-1 and 9-2 was built in 1994 and spans Ikes Creek, a non-navigable waterway in a residential neighborhood. The bridge is a single opening culvert that consists of five (5) precast concrete segments. The structure measures 28 feet wide with a length of 24 feet. Traffic guardrails are offset four (4) feet from the side headwalls where the edge of asphalt pavement begins. Wingwalls at each corner of the culvert headwalls protect the embankment slope.

The findings observed in the field and noted in the 2019 FDOT inspection report are normal issues that will not compromise the structural integrity of the precast culvert and wingwalls. The observations and findings for this bridge are of low priority repairs. It is recommended to routinely perform basic maintenance such as concrete spall or crack repairs, cleaning areas of debris and joint repairs to name a few.

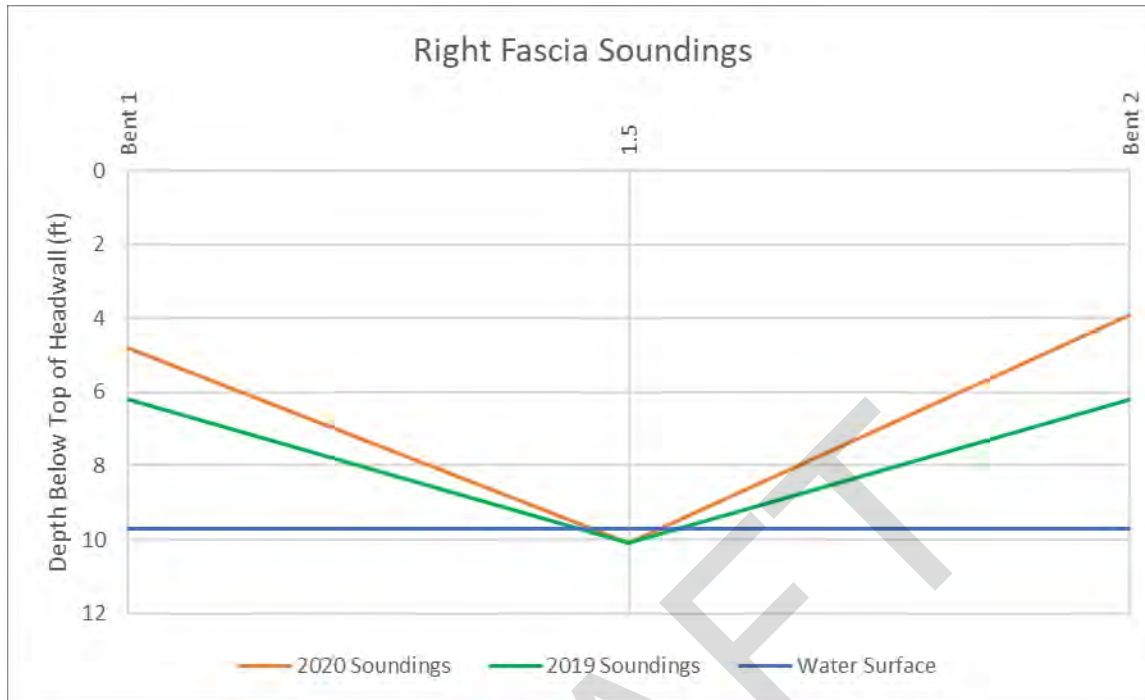
Graph 9-1 Bridge 155004 Right Fascia Cross Section

STATION	Fascia Left 2020	Fascia Left 2019	Fascia Left Change	Fascia Right 2020	Fascia Right 2019	Fascia Right Change
Bent 1	8.4	9.3	+0.9	4.8	6.2	+1.4
1.5	9.8	10.5	+0.7	10.1	10.1	0.0
Bent 2	8.0	9.9	+1.9	3.9	6.2	+2.3

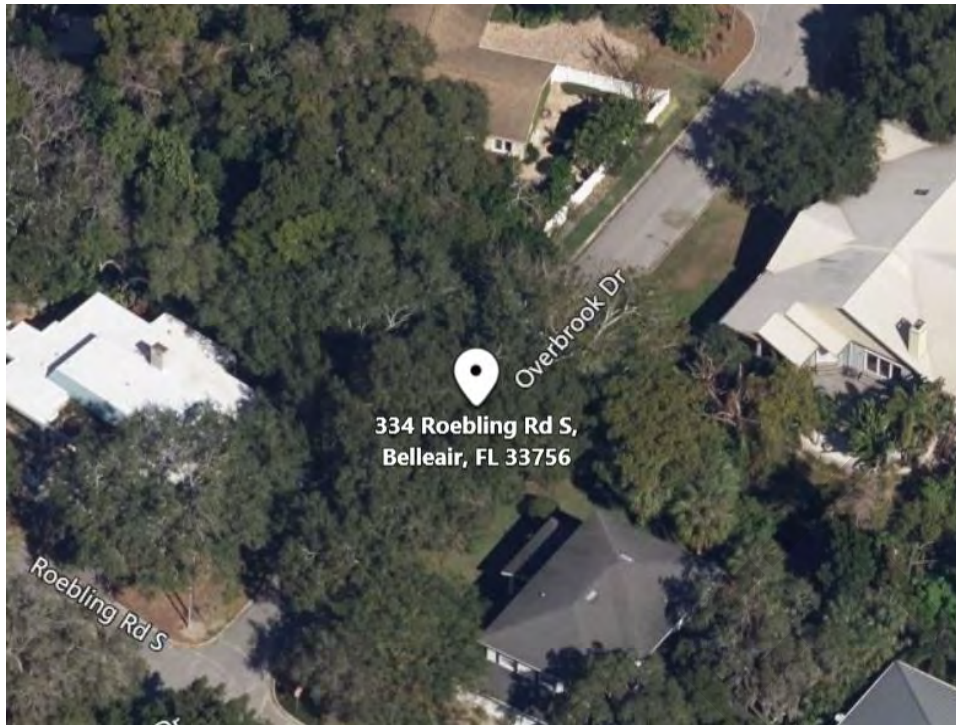
Figure 9-2: Aerial view of Bridge 155004 at Overbrook Drive

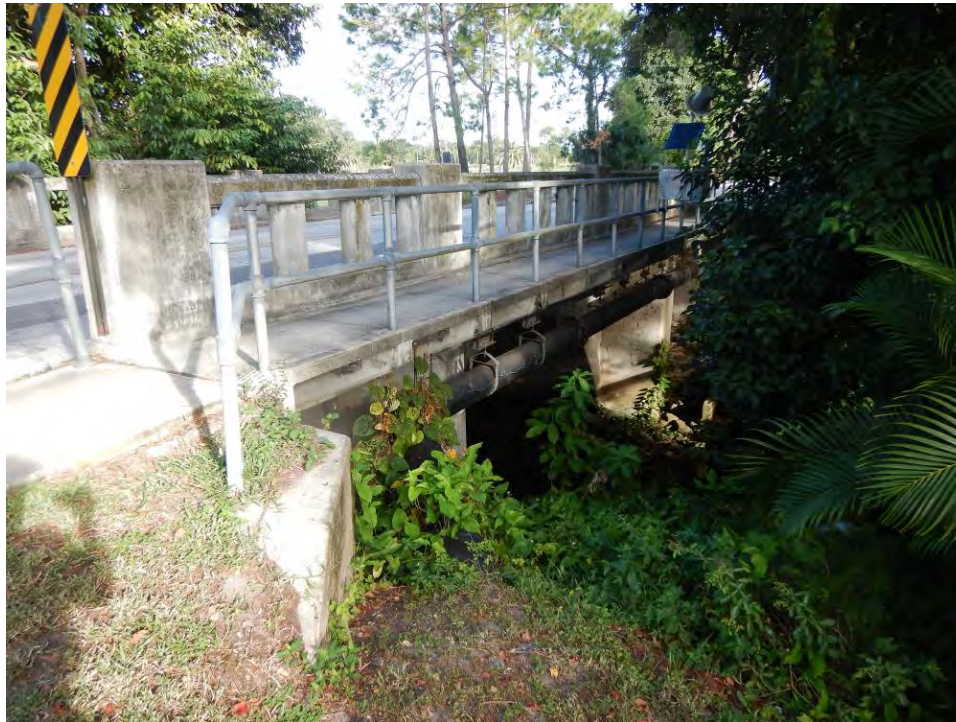
Figure 10-1: Bridge 150062 at Bayview Drive

Bridge 150062 at Indian Rocks Road, shown in Figures 10-1 and 10-2 was built in 1927 and spans Ikes Creek, a non-navigable waterway in a residential neighborhood. The bridge is an arch structure with a 27-foot channel opening that supports the roadway deck. The span measures 31 feet wide with a length of 57.5 feet. The bridge includes an asphalt overlay roadway surface and a four (4) foot raised concrete sidewalk on the east end. Concrete barriers are along the main span of the traffic lanes and the sidewalk is protected by a galvanized pipe railing at the edge of the deck. Wingwalls at each corner of the abutments protect the embankment slope.

The findings observed in the field and noted in the 2019 FDOT inspection report are normal issues that will not compromise the structural integrity of the bridge and wingwalls. The observations and findings for this bridge are of low priority repairs. It is recommended to routinely perform basic maintenance such as concrete spall or crack repairs, cleaning areas of debris and joint sealant repairs.

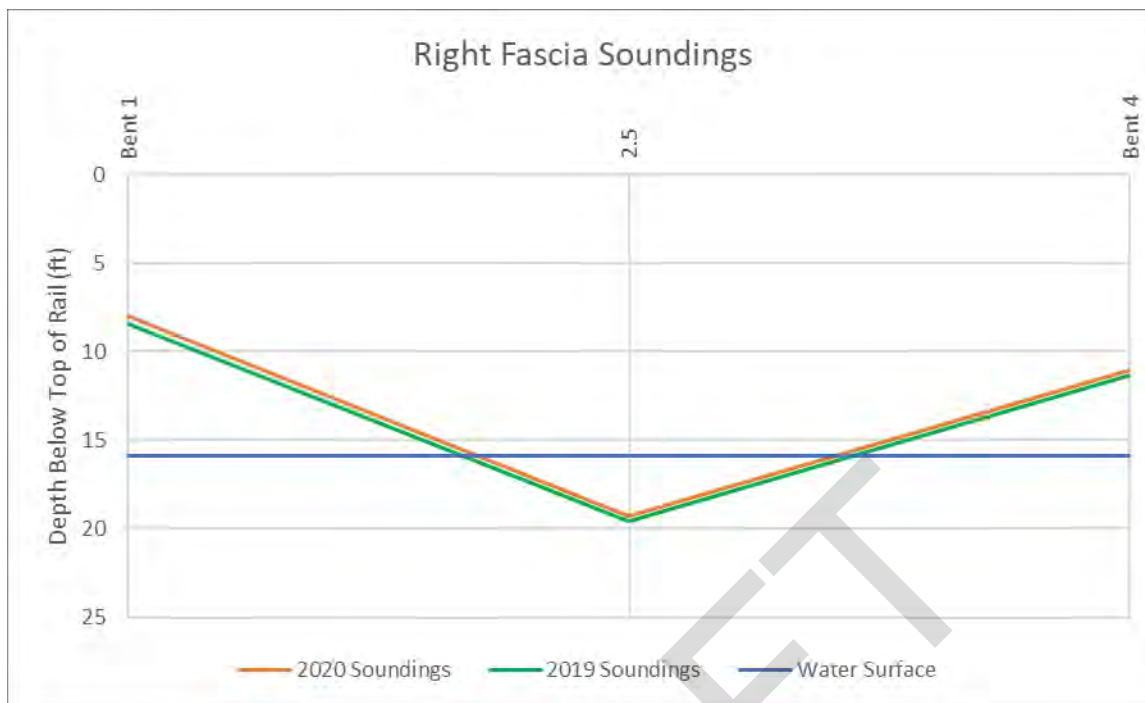
Graph 10-1 Bridge 155062 Right Fascia Cross Section

STATION	Fascia Left 2020	Fascia Left 2019	Fascia Left Change	Fascia Right 2020	Fascia Right 2019	Fascia Right Change
Bent 1	8.4	8.5	+0.1	8.0	8.4	+0.4
2.5	19.6	19.4	-0.2	19.3	19.6	+0.3
Bent 4	7.6	7.3	-0.3	11.0	11.3	+0.3

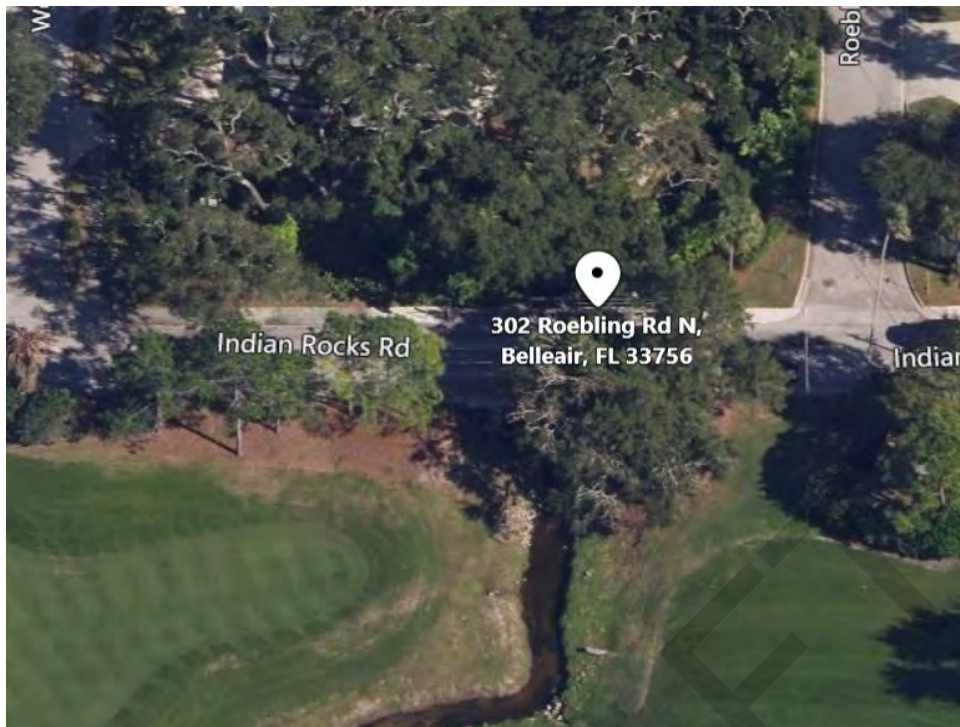
Figure 10-2: Aerial view of Bridge 155062 at Indian Rocks Road
